REPORT MARINE 2024/05

*Loss of propulsion and near grounding of
Viking Sky, Hustadvika, Norway
23 March 2019*

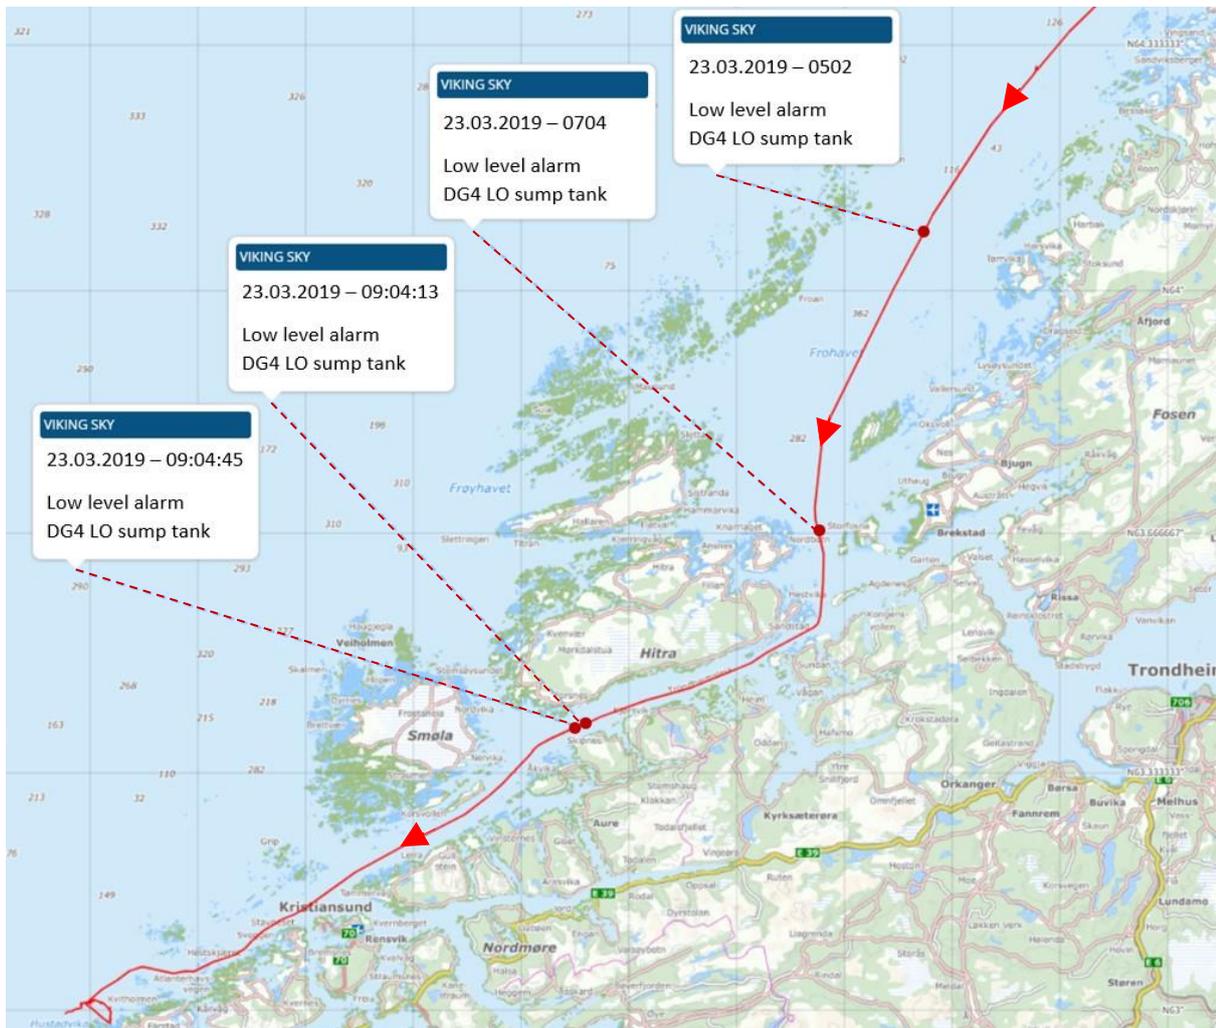
The four low lube oil level alarms were acknowledged with no further action taken by the engineer on watch. They all reverted to pre-alarm condition within one minute and were cleared from the screen by the alarm system. For a detailed description of the alarm system, see section 1.10.

Figure 4: Lube oil sump alarms in the time period from 0502 until 0904. Illustration: The Norwegian Coastal Administration AIS / NSIA

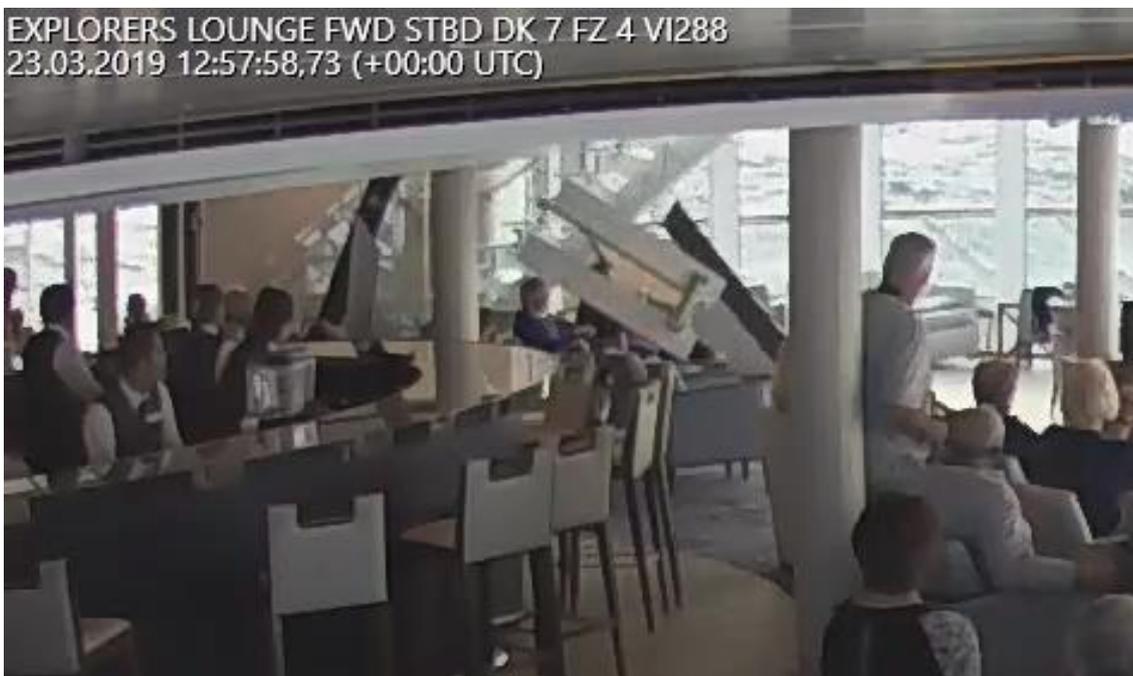
Figure 10: Ceiling plates falling down in the Explorer's Lounge at the time of the blackout. Photo: CCTV

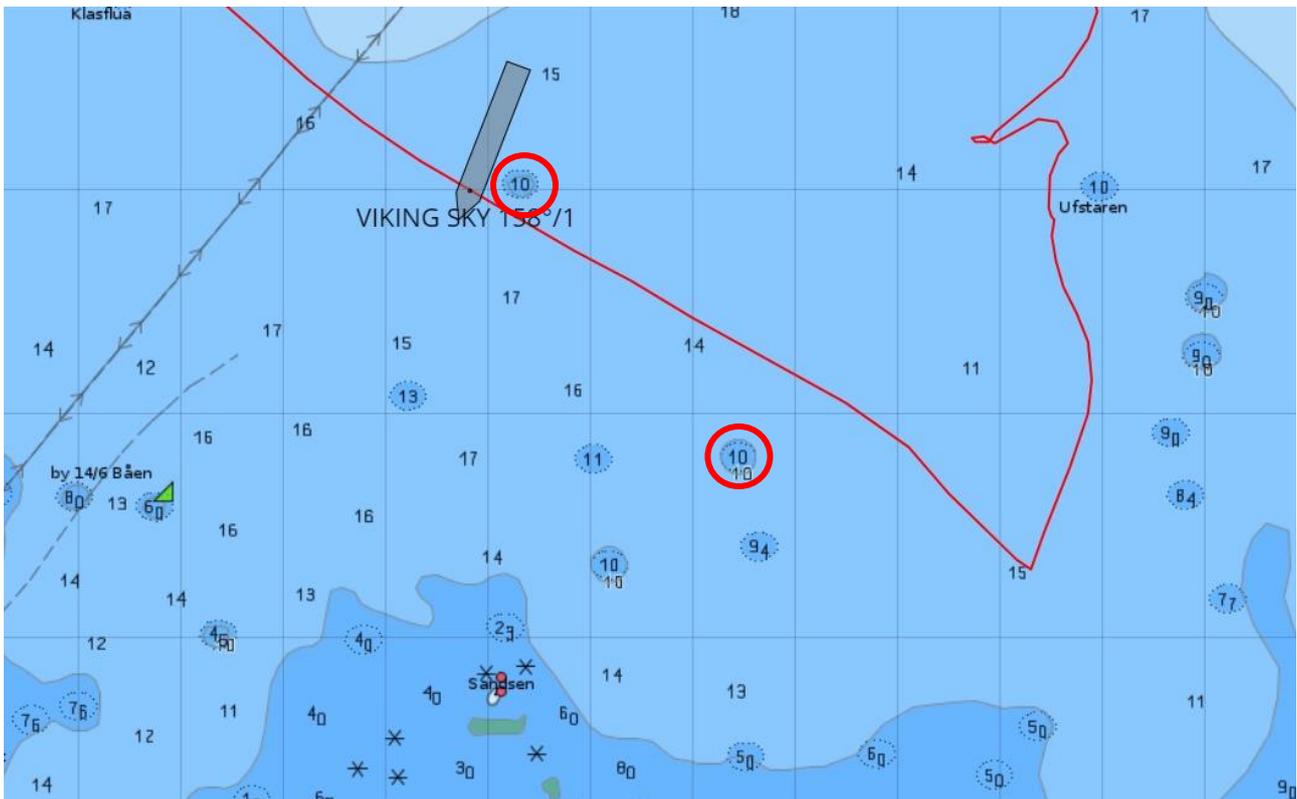
At 1427, the vessel drifted over a rock charted at 10 metres depth, as illustrated in Figure 13. The vessel's draft was approximately 6.5 m and the average wave height was estimated to 4–6 m according to the entry in the deck log book. According to a weather report from the Norwegian Meteorological Institute the significant wave height was 8–9 m in the area at the time.

Figure 13: Viking Sky at 1427, drifting over a rock at a depth of 10 metres. Source: The Norwegian Coastal Administration AIS

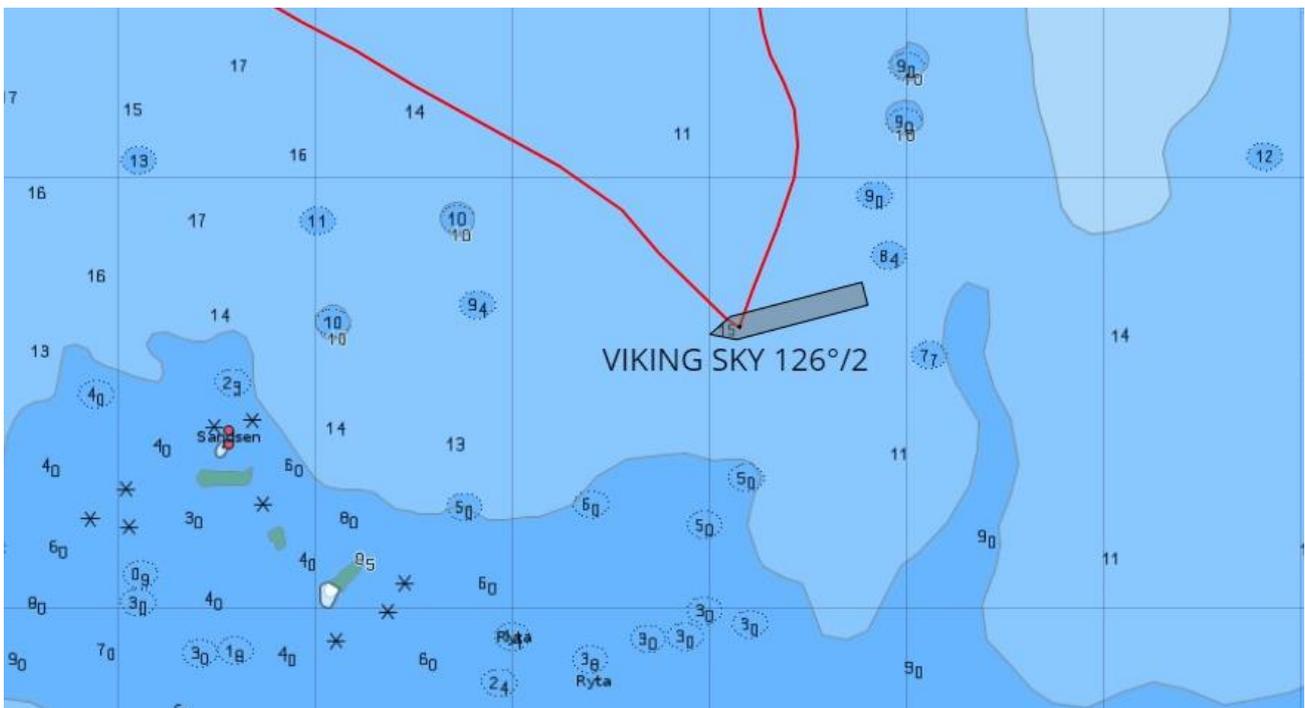
Figure 14: Viking Sky at 1437, a ship's length from running aground. Source: The Norwegian Coastal Administration AIS

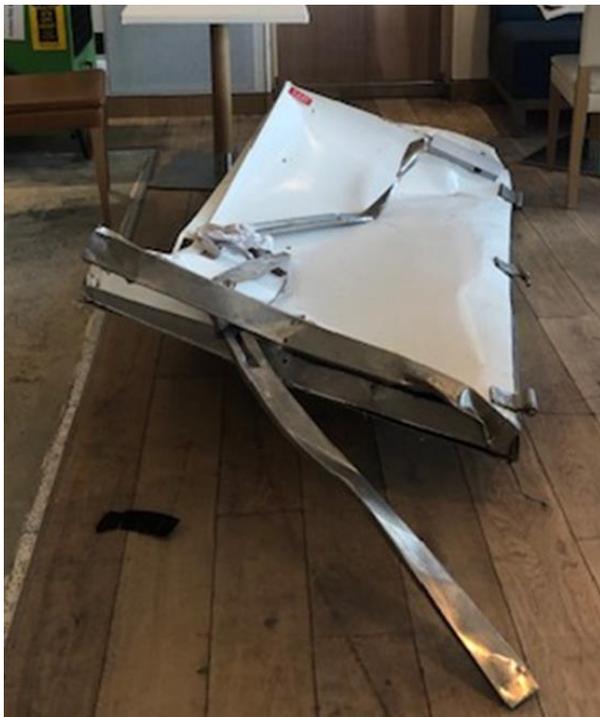
There were some cracked windows on deck 7. The door from the outside deck on the starboard side into the restaurant on deck 2 was broken due to a wave impact shortly after 1500, see Figure 23. This is also considered the most likely time for all the damage on the starboard side to have occurred, including lifeboat no. 3, see Figure 24, all the lifeboat davit control stations, the gangway bracket, the railings from D2 to D3 and the lifejacket boxes. The starboard stabiliser was also damaged.

Figure 23: Broken door in the restaurant at deck 2.
Photo: NSIA

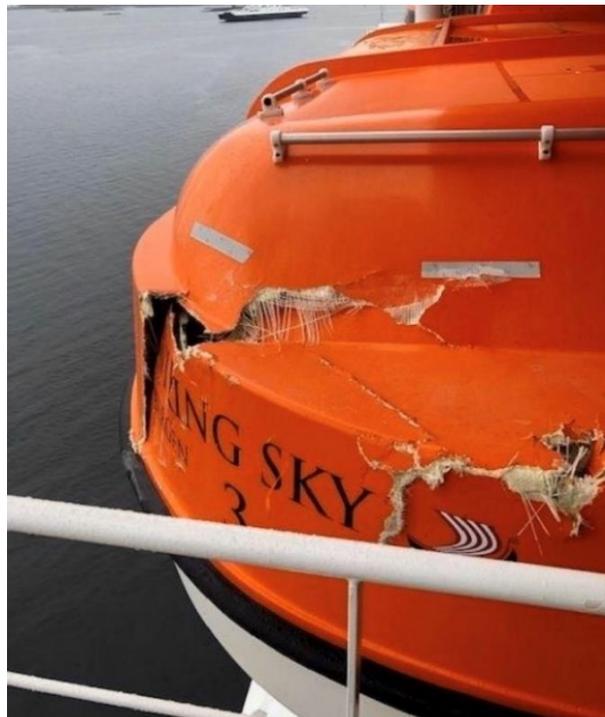
Figure 24: Damage to lifeboat on starboard side.
Photo: NSIA

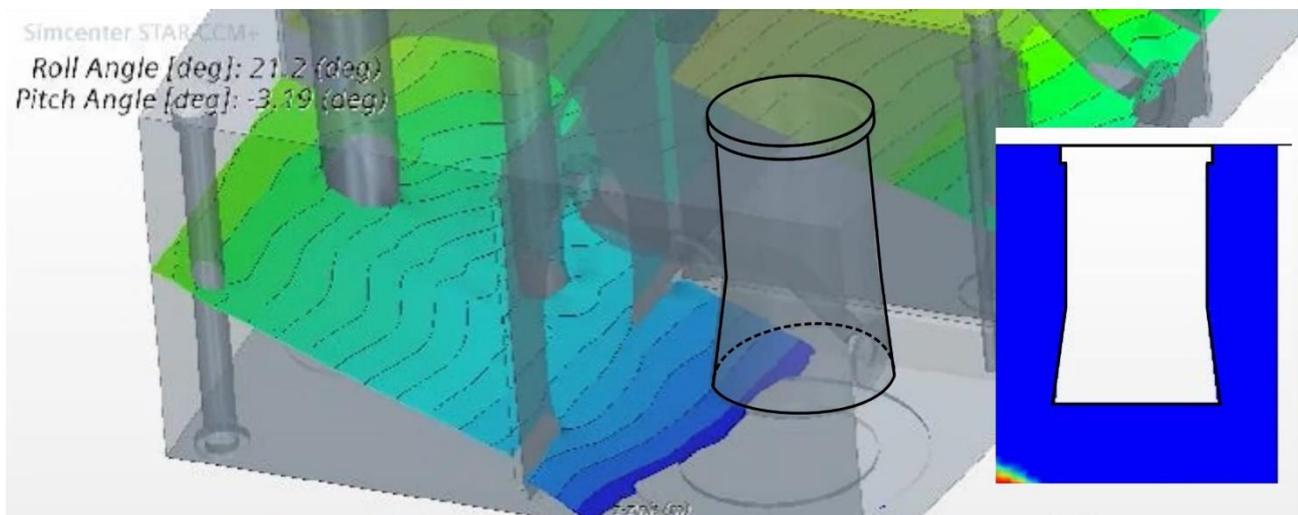
Figure 51: Illustration from the CFD simulation showing the suction pipe completely exposed to air. The multi-coloured surface represents the surface of the oil. The illustration in the box to the right shows a 2D side view of the suction pipe. Source: SINTEF Ocean/NSIA

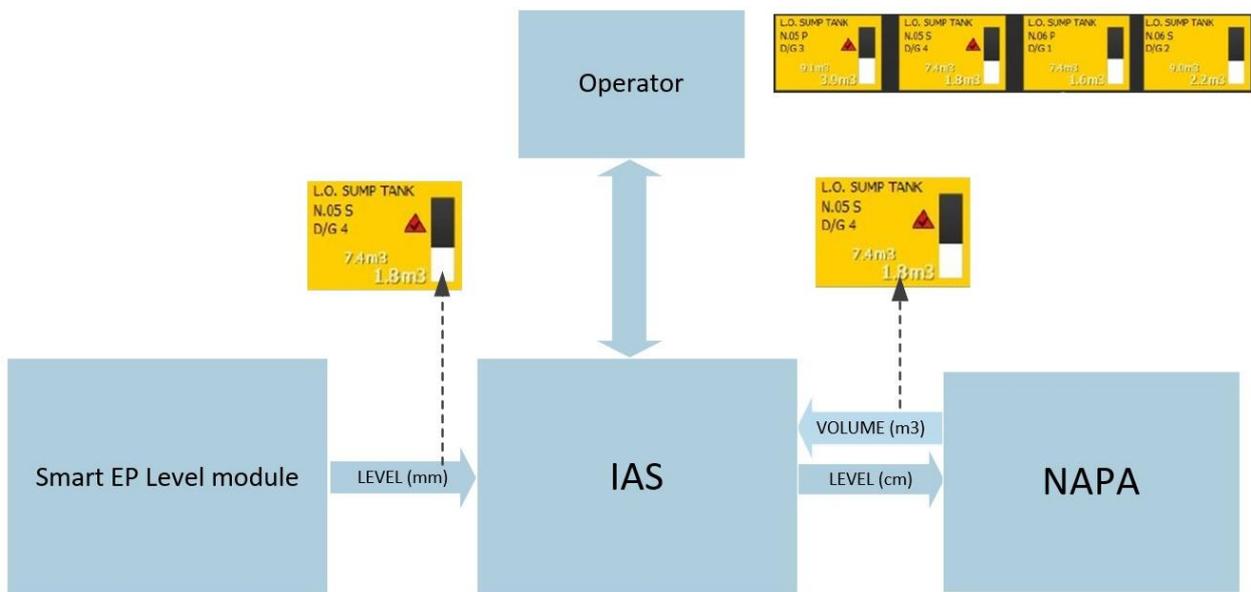
Figure 62: Inconsistency in volume shown in mimics. Source: IAS/NSIA

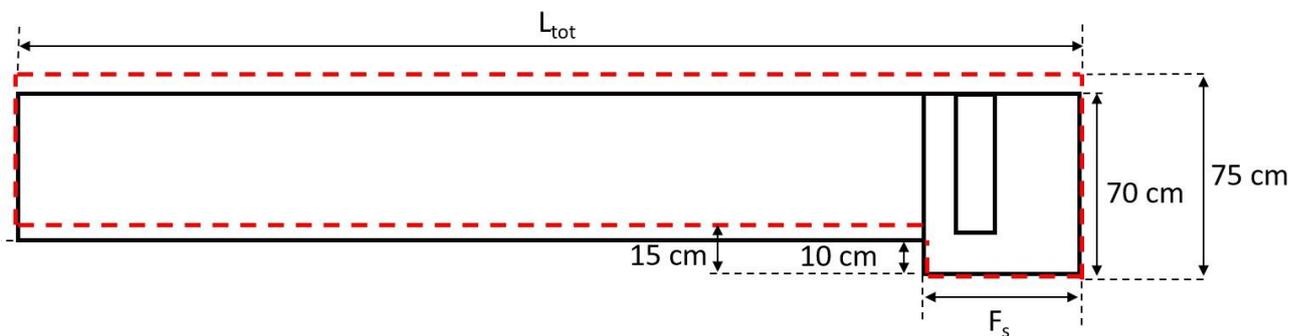
Figure 63: Actual tank (black contour) and the erroneous model (red dotted line). Illustration: NSIA

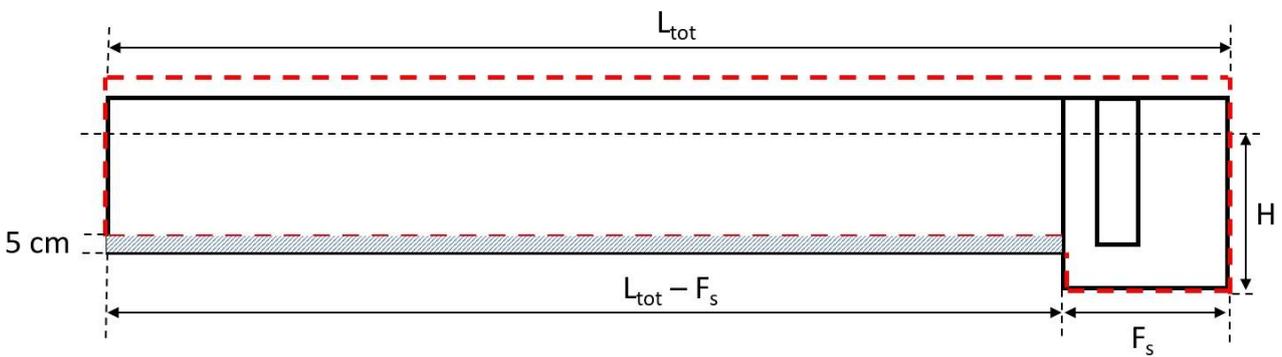
Figure 66: Difference in oil volume between a correct and the erroneous model. Illustration: NSIA
