REPORT MARINE 2024/05

*Loss of propulsion and near grounding of
Viking Sky, Hustadvika, Norway
23 March 2019*

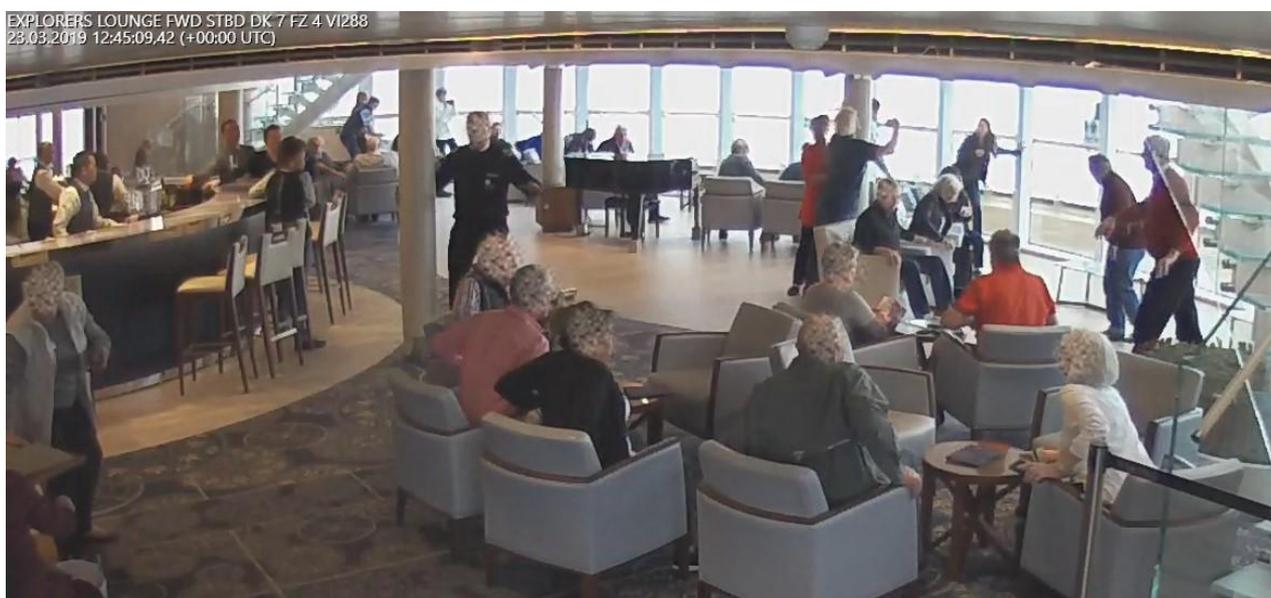
Figure 7: Crew telling passengers to move to carpeted area after chairs starting to slide sideways on the hard floor in the Explorers' Lounge right after DG4 and DG2 shutdown. Photo: CCTV

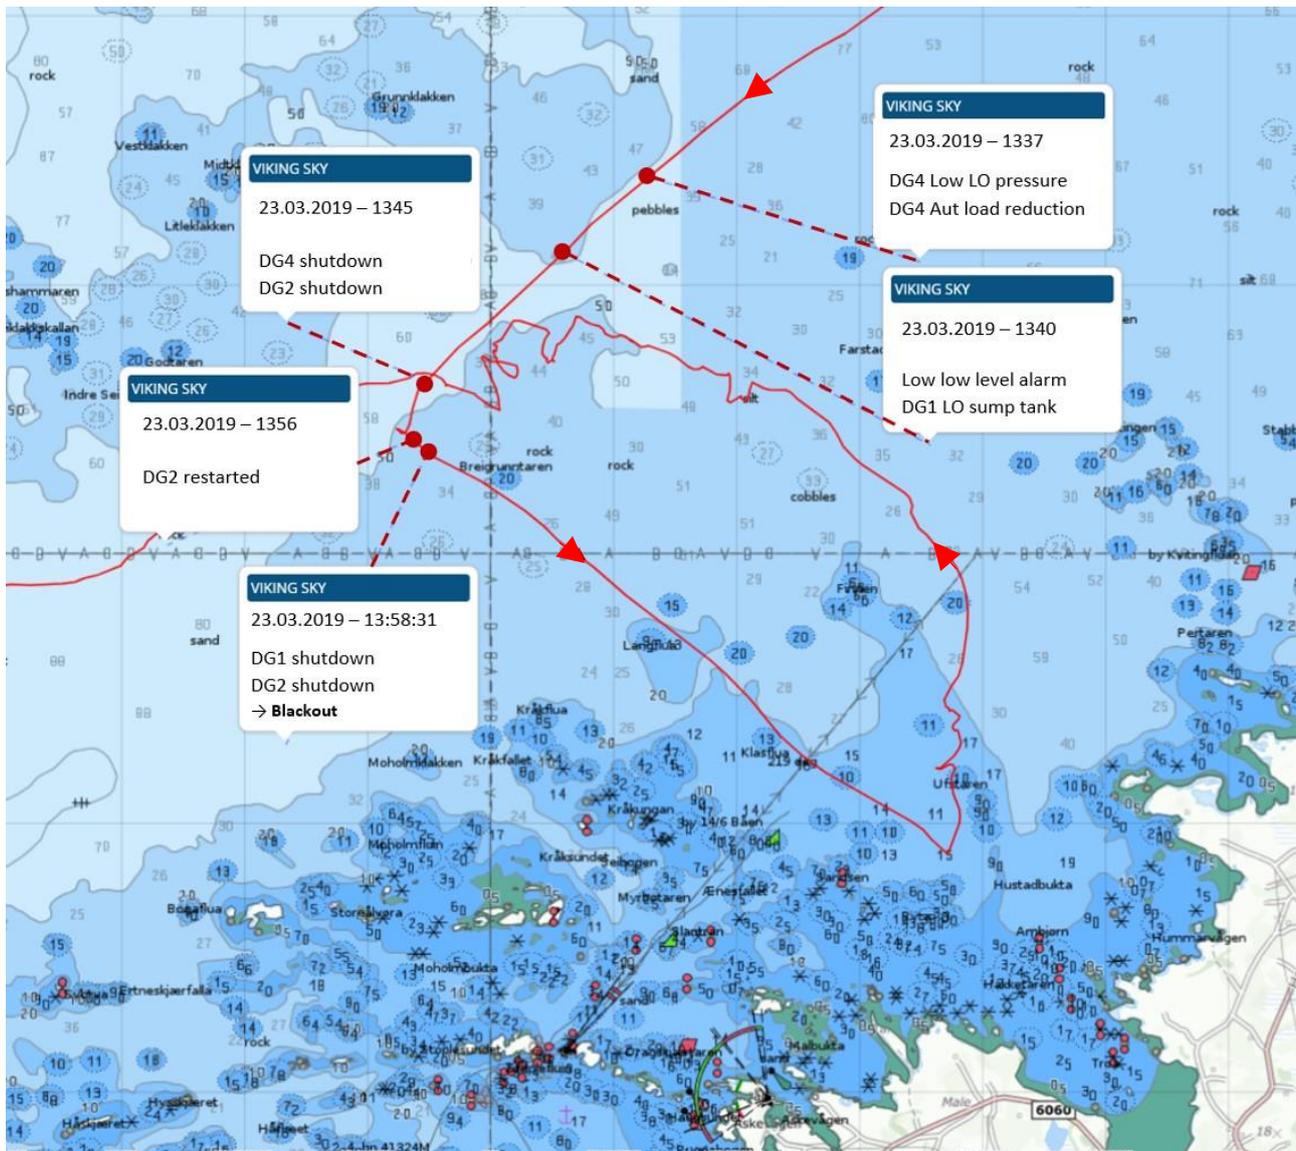
At 1356, approximately 11 minutes after the shutdowns, DG2 was successfully restarted and the stabilisers were manually deployed to the operational position. Less than three minutes later, at 13:58:31, DG1 and DG2 shut down, causing a blackout and loss of propulsion and steering.

Figure 8: Events from 1337 until blackout. Illustration: The Norwegian Coastal Administration AIS / NSIA

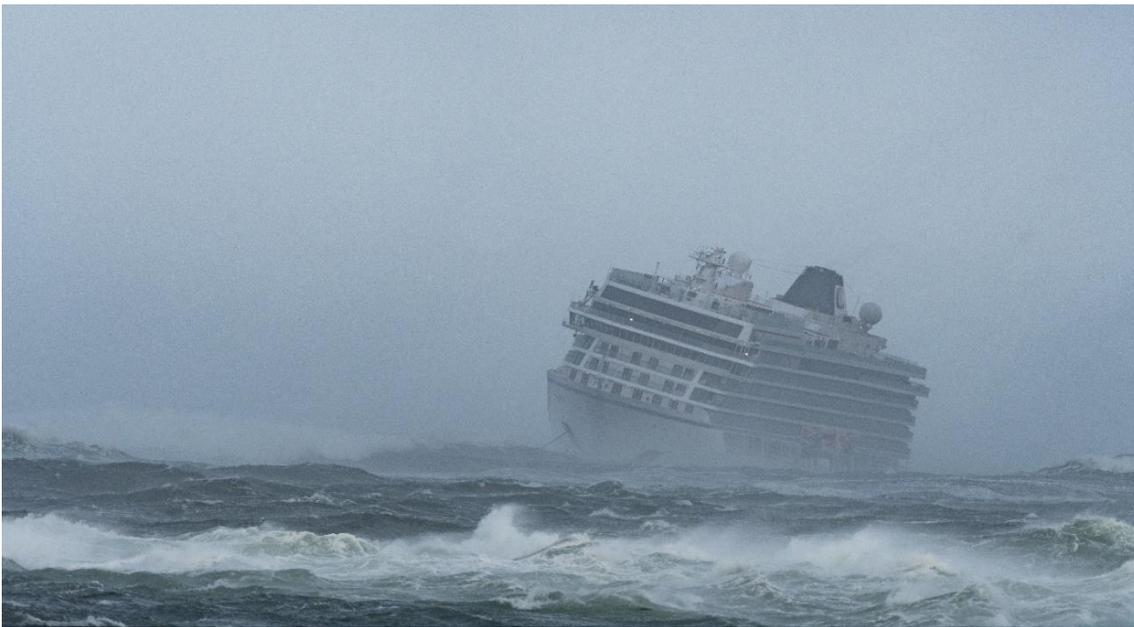
Having assessed the situation, the captain broadcast a Mayday at 1400. He then instructed the crew to drop both anchors, and the crew were deployed to prepare them. A few minutes later, they started to lower the starboard anchor, and then the port anchor, both with ten shackles in the water. However, the anchors did not hold, and the ship continued to drift. The average wind during

this period was 24 m/s (BF9, strong gale force)¹⁰ with gusts to 35 m/s. The ship drifted towards the shore at an average speed of about 4 knots, dragging the anchors along the seabed.

Figure 9: Viking Sky drifting towards the shore. Photo: Eva Frisnes

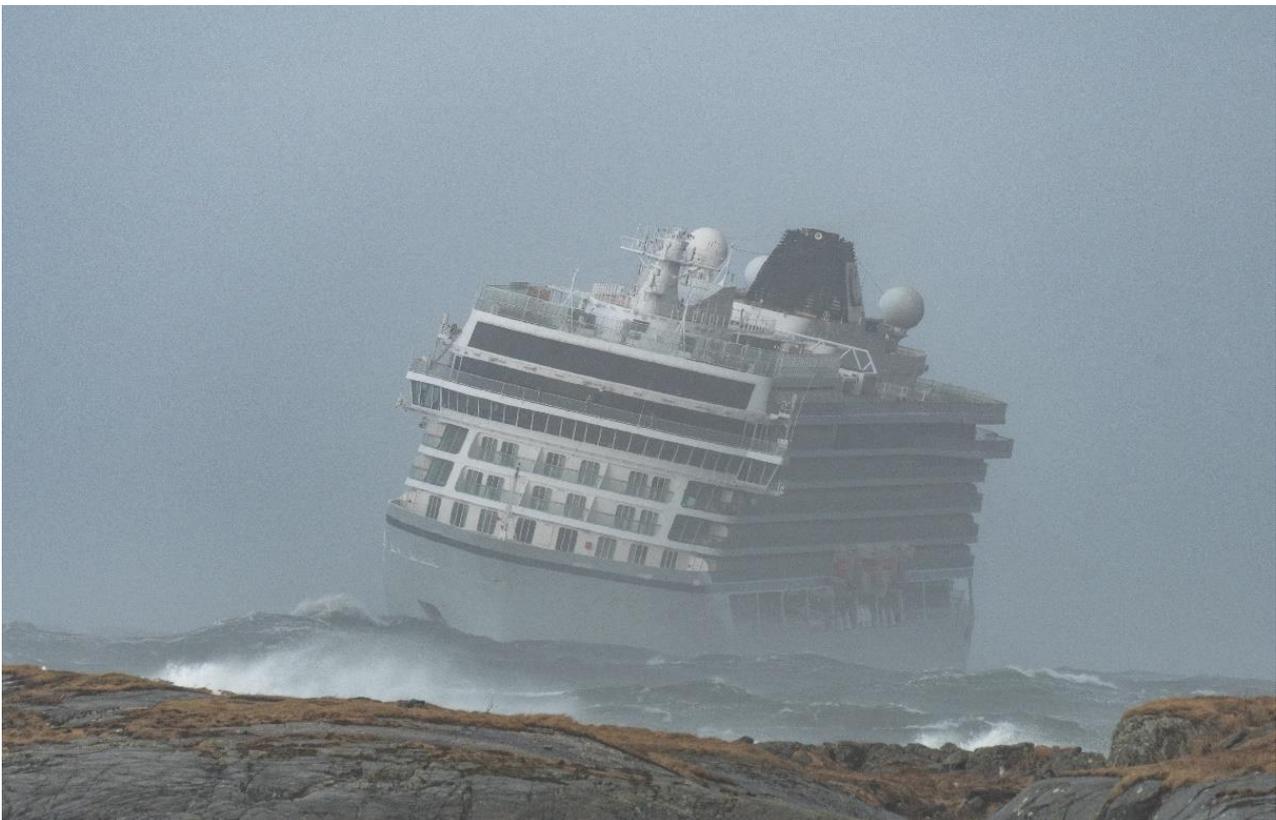
Figure 11: Viking Sky in the immediate vicinity of several shallows and rocks. Photo: Eva Frisnes

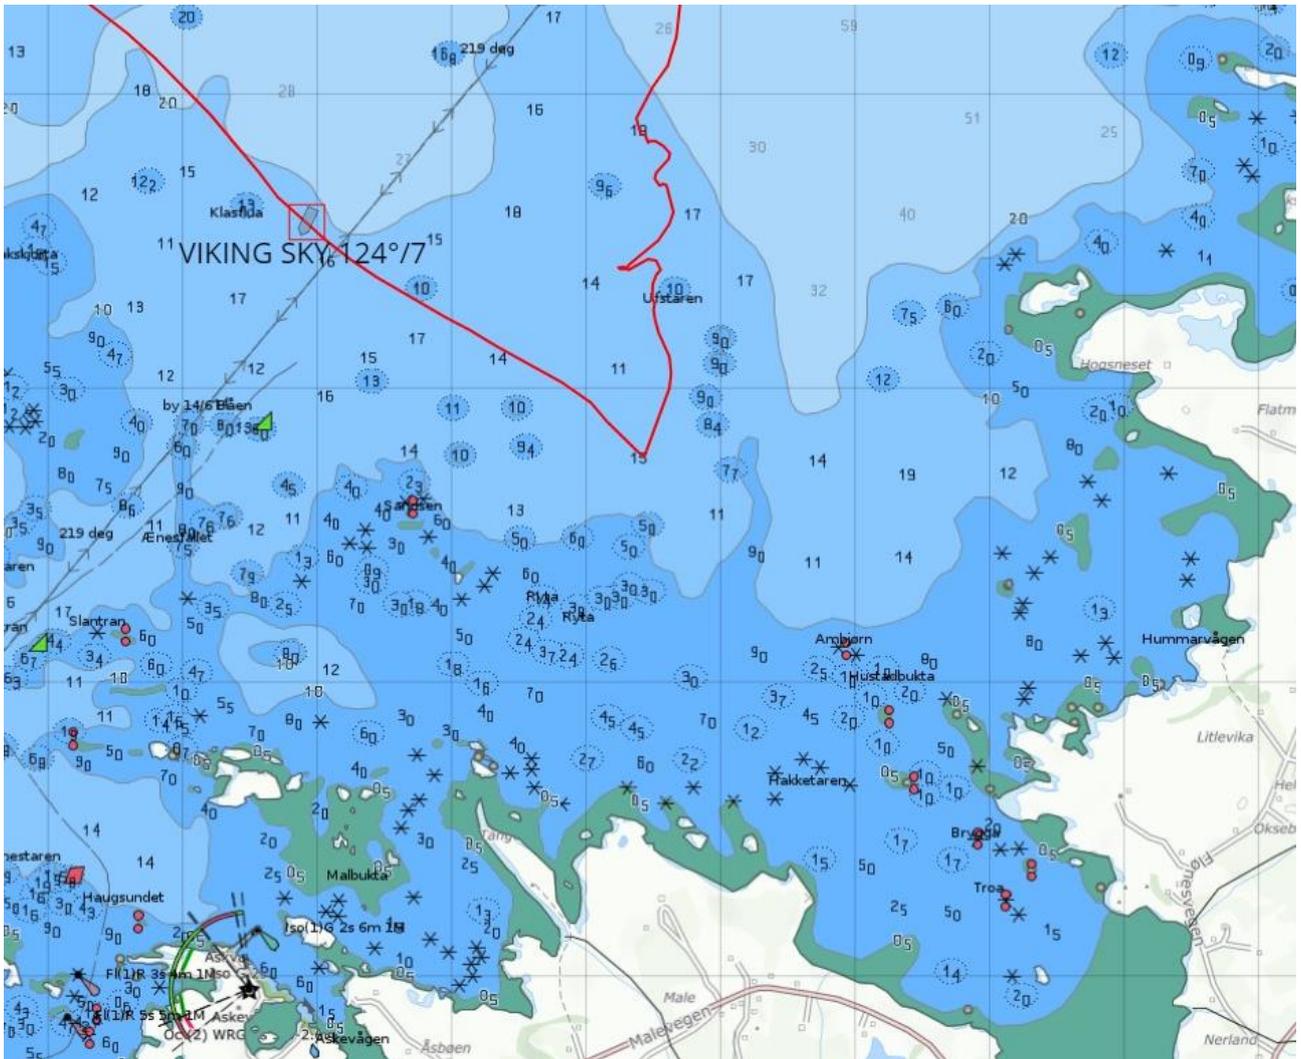
At 1422 DG2 was successfully restarted and connected to the Main Switch Board (MSB) in local manual control mode. At this time, the ship was in the immediate vicinity of several shallows and rocks, see Figure 11 and Figure 12.

Figure 12: Viking Sky at 1422, in area with shallow banks and rocks. Source: The Norwegian Coastal Administration AIS

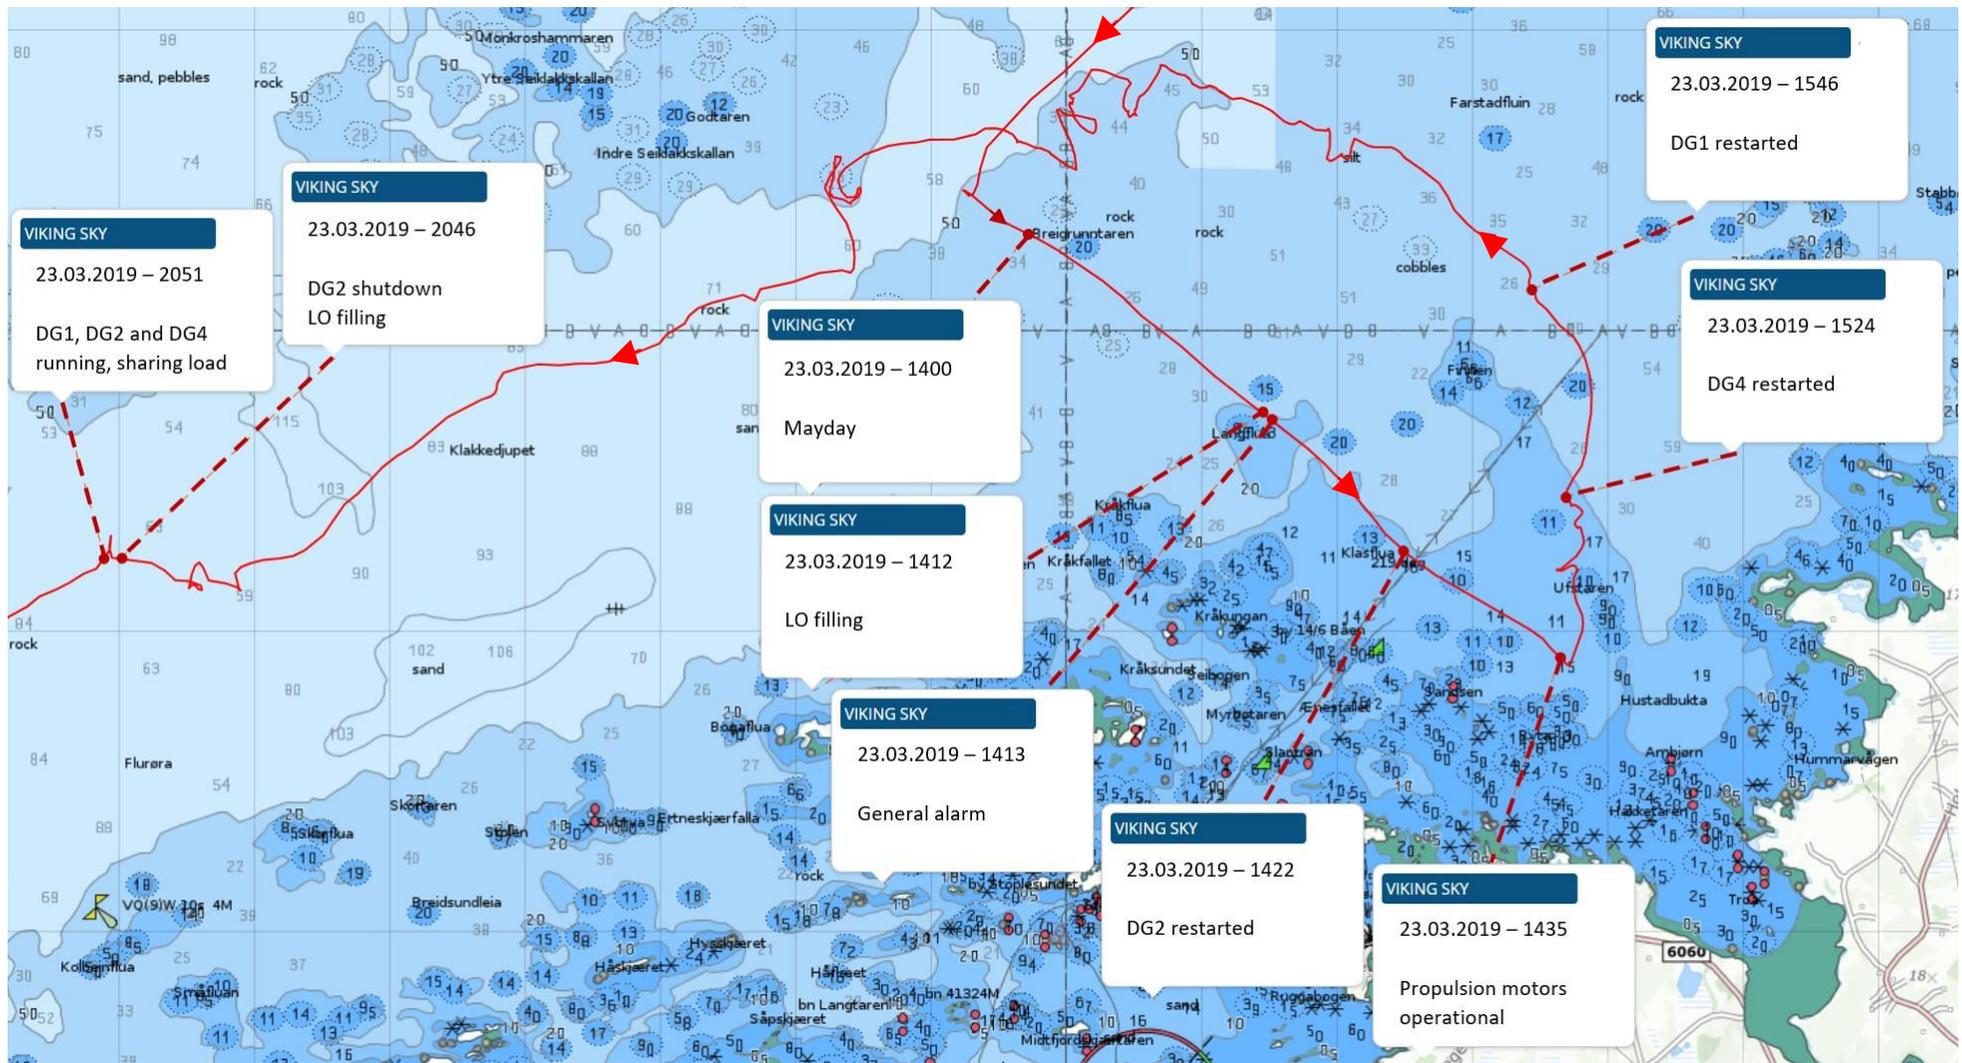
DG4 and DG1 were restarted and connected to the MSB in automatic load-sharing mode at 1524 and 1546 respectively, see Figure 15. Due to the proximity of the vessel to shallow waters and a concern that there might be an issue with the engines' control system, the engineers did not want to risk another blackout by attempting to switch DG2 to automatic. DG2 was therefore left in manual mode which meant that the electrical load on DG2 had to be manually controlled and did not automatically share load with DG1 and DG4. Only some load was taken by DG1 and DG4, while DG2 was taking most of the load.

At approximately 2046, DG2 again shut down on low lube oil pressure. Additional lube oil was pumped into its sump tank. After switching the DG to remote control and automatic load sharing mode, it was successfully restarted and connected to the MSB after about 5 minutes. DG1, DG2 and DG4 were now all running, and the power management system automatically shared the load between them.

Figure 15: Events during restoration of power. Source: The Norwegian Coastal Administration AIS / NSIA

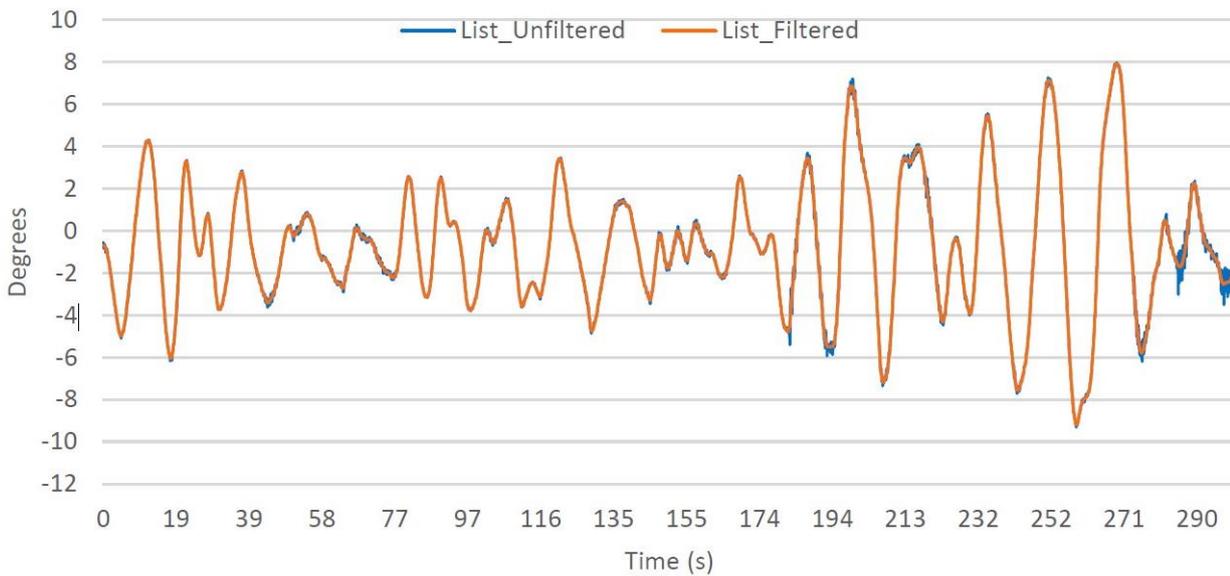
noise was primarily above 1 Hz frequency. The noise had a relatively small influence on the roll angle, but for the purpose of the CFD calculations a low pass filter with a cut-off of 0.8 Hz was used to remove all frequencies above 0.8 Hz.

Figure 25: Angle of list (roll), filtered and unfiltered signal. Source: Eniram data / SINTEF Ocean's CFD report

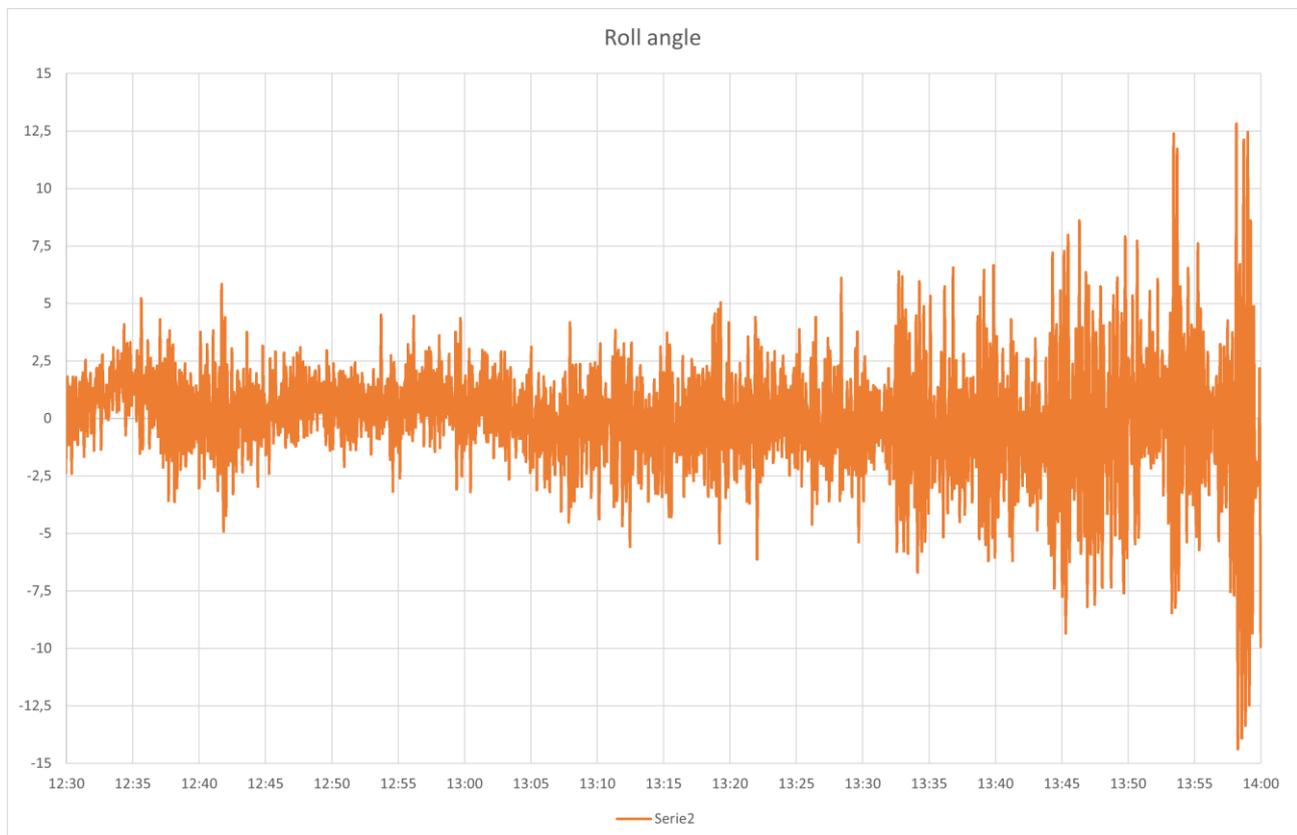
Figure 26: Roll angle registered by Eniram 1230 to 1400 LT. Source: Eniram/NSIA

Viking Sky entered Hustadvika at approximately 1230 LT, experienced the first engine shut down at 1345 and the blackout at 1358. As described in the sequence of events and as shown in the graphical representation of the Eniram recordings in Figure 26, the angle of roll increased over this period and reached approximately 14 degrees at the time of the blackout.

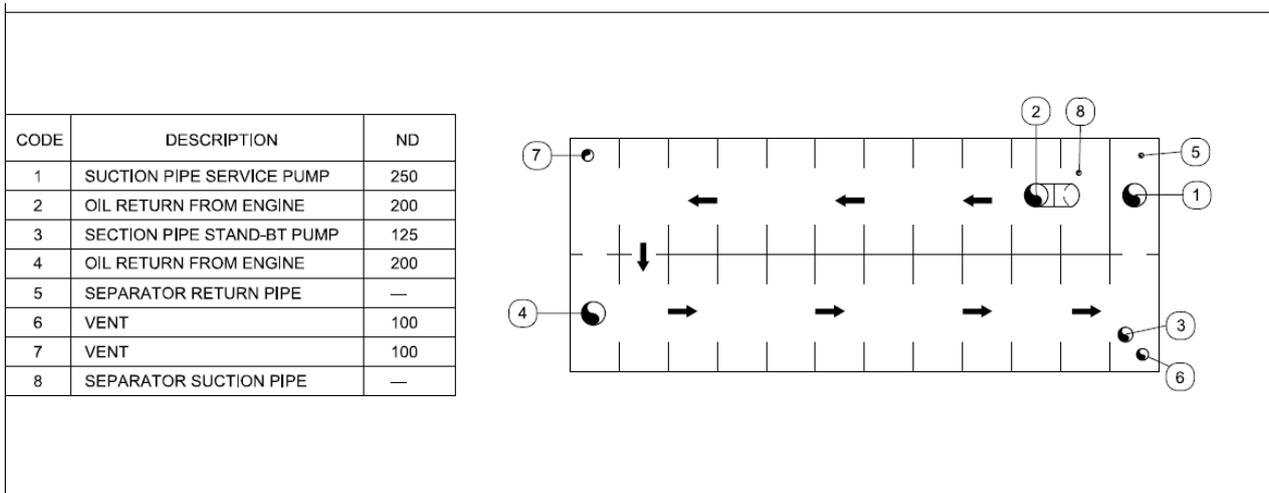
Figure 32: Extract from “Lube oil service system functional diagram”, showing a sump tanks’ baffle and pipework arrangement seen from above. Extract: Fincantieri

The engine-driven oil pumps took suction from the lube oil sump tank below the engines’ free ends, with oil returns located at both the free and alternator ends. The lube oil returns from the engines to the free ends were separated by a partition from the main lube oil pump suctions, see Figure 32.

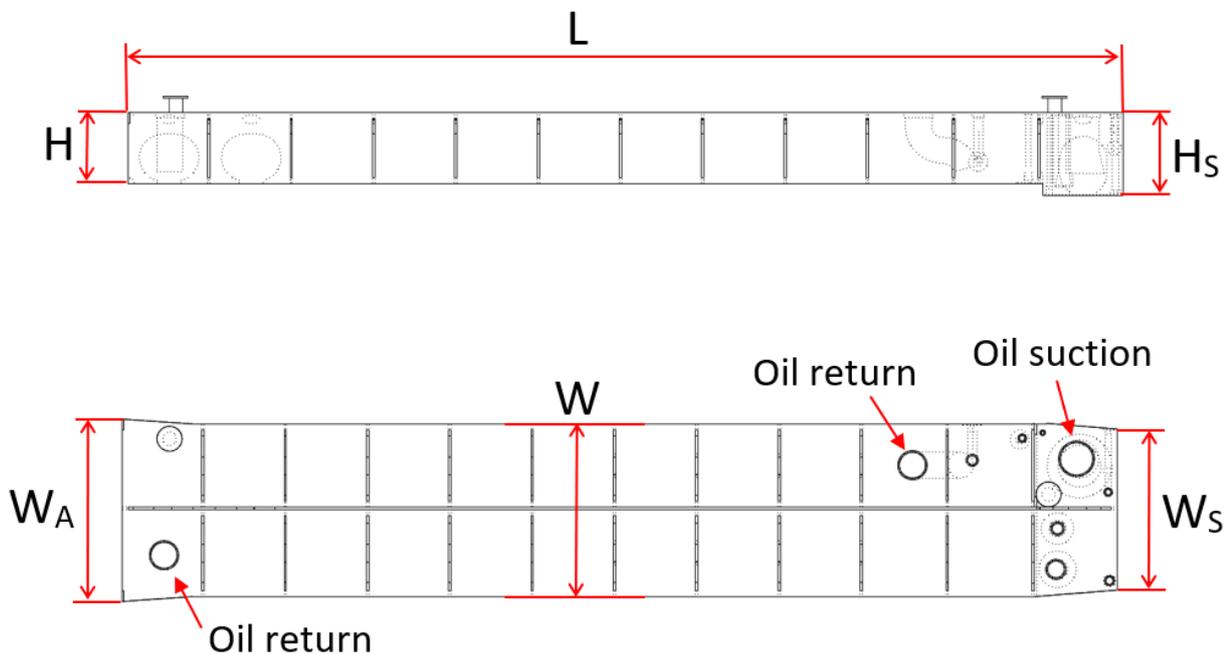
Figure 41 represents the geometry of lube oil sump tank 5S, which supplies DG4. The main geometry is similar for all sump tanks, therefore Figure 41 is used to illustrate the sump tanks as designed by the yard.

Figure 41: Side and top view of lube oil sump tank 5S, supplying DG4. Illustration: Fincantieri

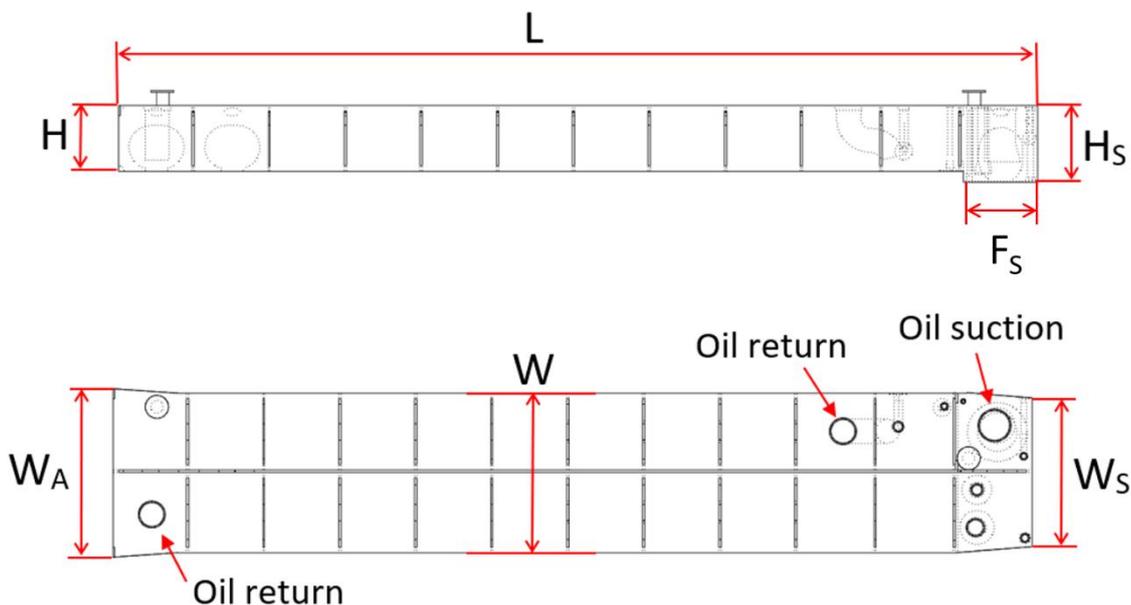
Figure 43: Side and top view of lube oil sump tank 5S, supplying DG4. Illustration: Fincantieri

All lube oil sump tanks are similar in shape. Table 4 provides the main dimensions highlighted in above illustration for each tank.

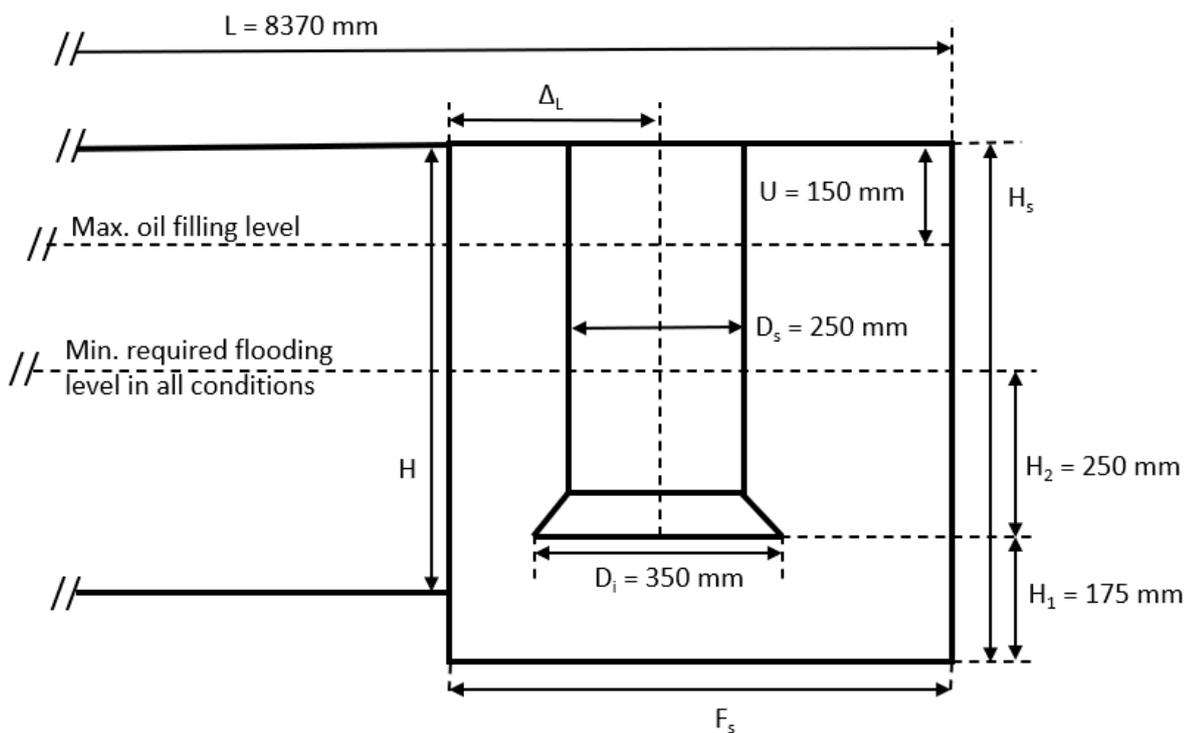
Figure 44 and Figure 45 provide details relevant to the suction end of the tank, the suction pipe position and indicate the minimum required flooding level in all conditions and the maximum oil filling level according to the MAN recommended design criteria.

Figure 44: Longitudinal section view of suction end. Illustration: NSIA

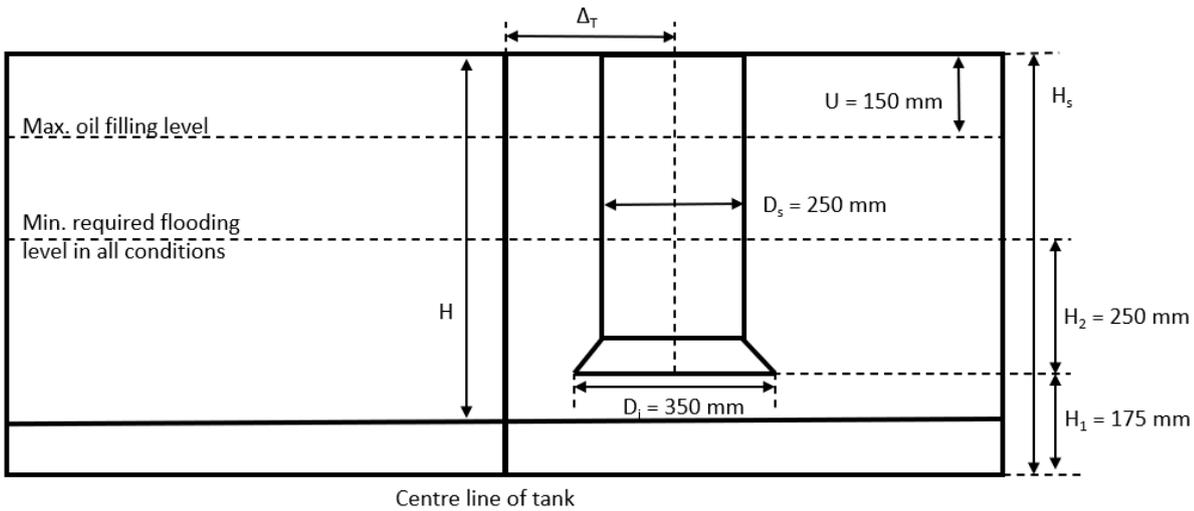
Figure 45: Transverse section view of suction end. Illustration: NSIA

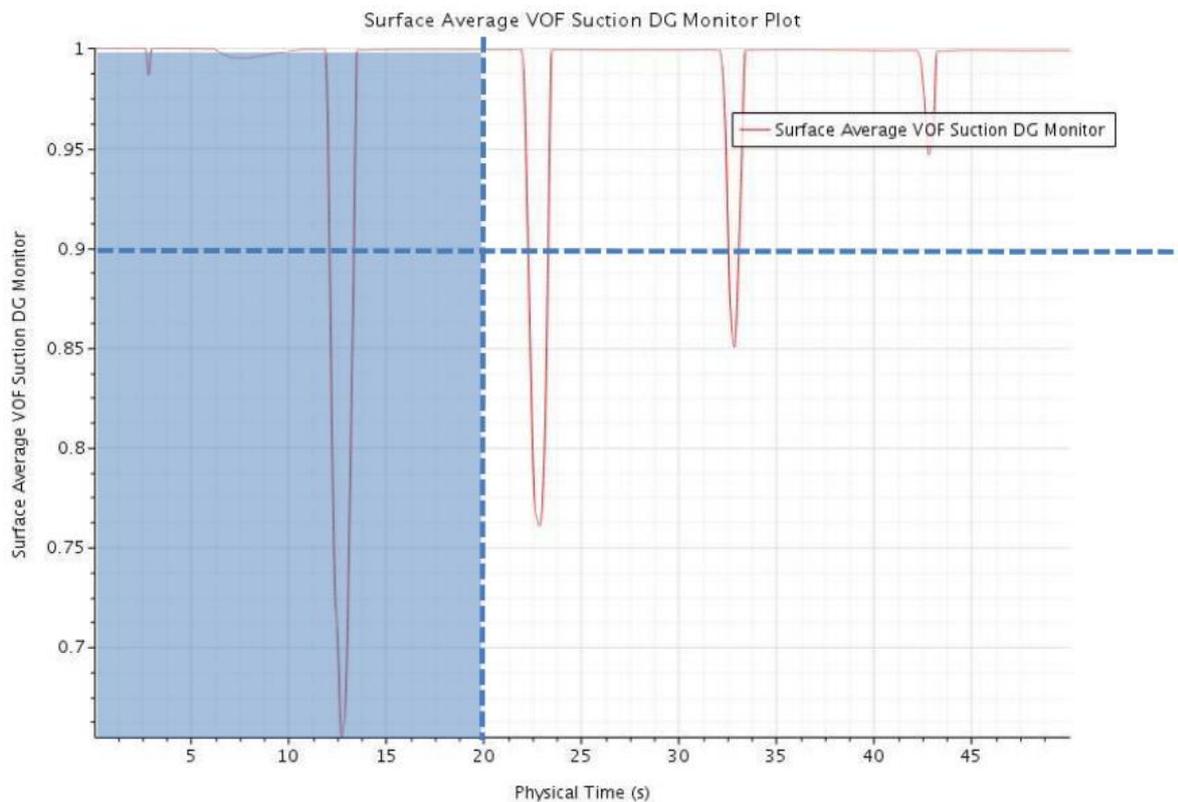
The dynamic simulation of lube oil behaviour in sump tank 5S (DG4) was carried out by applying harmonic pitch and roll motion with the amplitudes prescribed by SOLAS and Class, 7.5° pitch and 22.5° roll. Two simulations were made, both with a 10 second period for both pitch and roll motions, with maximum roll and pitch occurring simultaneously either with the motions in phase or in opposite phase.

Figure 5: time dependent behaviour of the VOF on the suction pipe in the “Design Scenario” with motions in phase.

Figure 50: Oil fraction at suction pipe inlet area, extract from the shipyard’s calculation report.

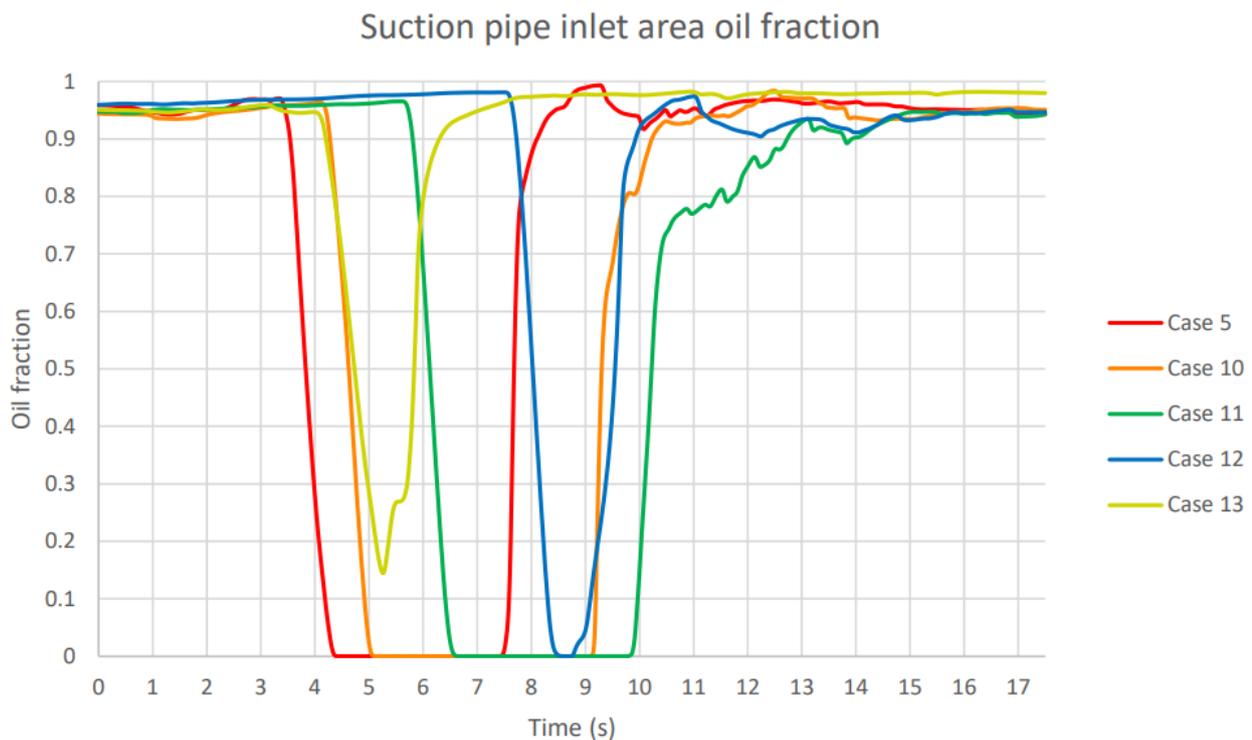
With the highest oil filling level recommended by the engine maker, this resulted in the suction pipe being completely exposed to air, see Figure 51, for about 4 seconds and partially exposed to air for approximately 6 seconds as illustrated by Case 10 in Figure 52.

Figure 52: Oil fraction at suction pipe inlet area. Case 10 represents the worst case. Source: SINTEF Ocean's CFD calculation

The coloured graphs in the above Figure 52 represent the fraction of the suction pipe inlet opening that is covered by oil. An oil fraction of 1 indicates that the suction pipe inlet opening is fully covered by oil. Due to a slight mixture of air in the oil, this fraction remains slightly below 1 even when the inlet opening is fully submerged in the mixed fluid. When the graph indicates a steep drop, the edge of the inlet opening has been exposed to air and the fraction of the opening exposed to oil therefore decreases. When the graph reaches the value of 0, the complete opening of the suction pipe inlet is exposed to air. The different cases represent different input parameters, as specified in the report in Appendix F.

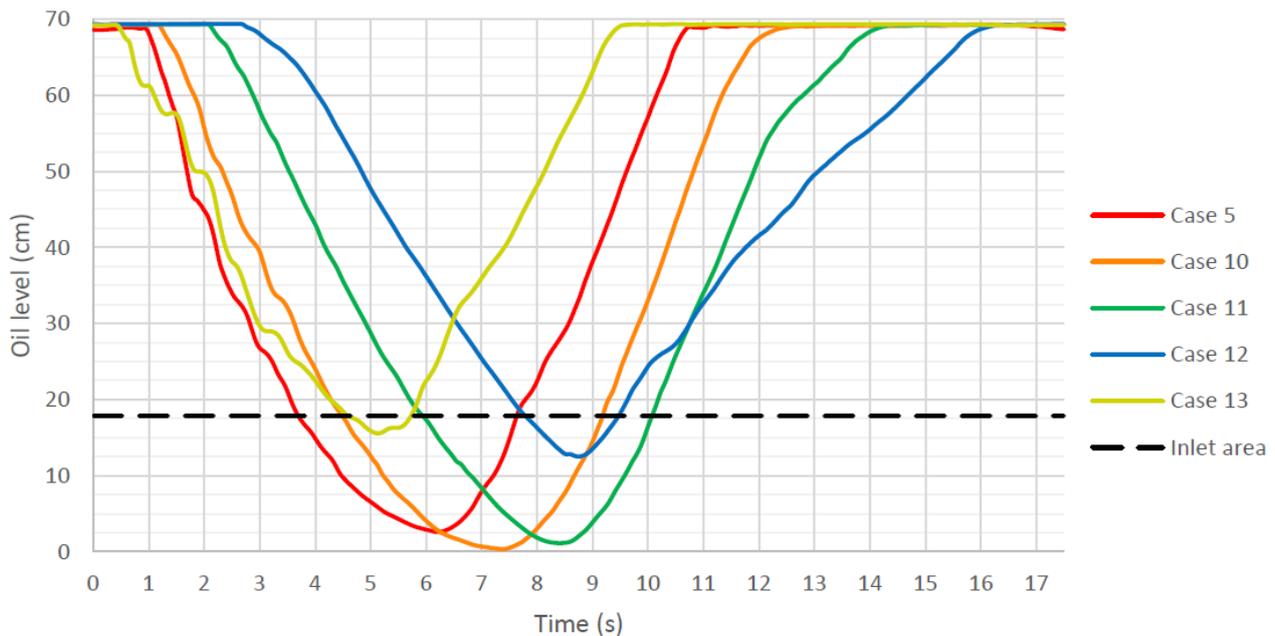
Figure 53 shows the same simulation results as Figure 52, but the coloured graphs indicate the oil level at the suction pipe. The dotted horizontal line shows the height of the suction pipe inlet and the 0-level indicate the tank bottom. When the graph crosses below the dotted line, the oil no longer reaches the suction pipe opening and the suction pipe is consequently exposed to air.

As the graphs represent a full motion period (17.5 seconds) after periodic behaviour is reached, the oil level is in constant motion and fluctuates around the filling level (55 cm) up to the tank height at 70 cm.

Figure 53: Oil level at suction pipe. Case 10 represents the worst case. Source: SINTEF Ocean's CFD calculation

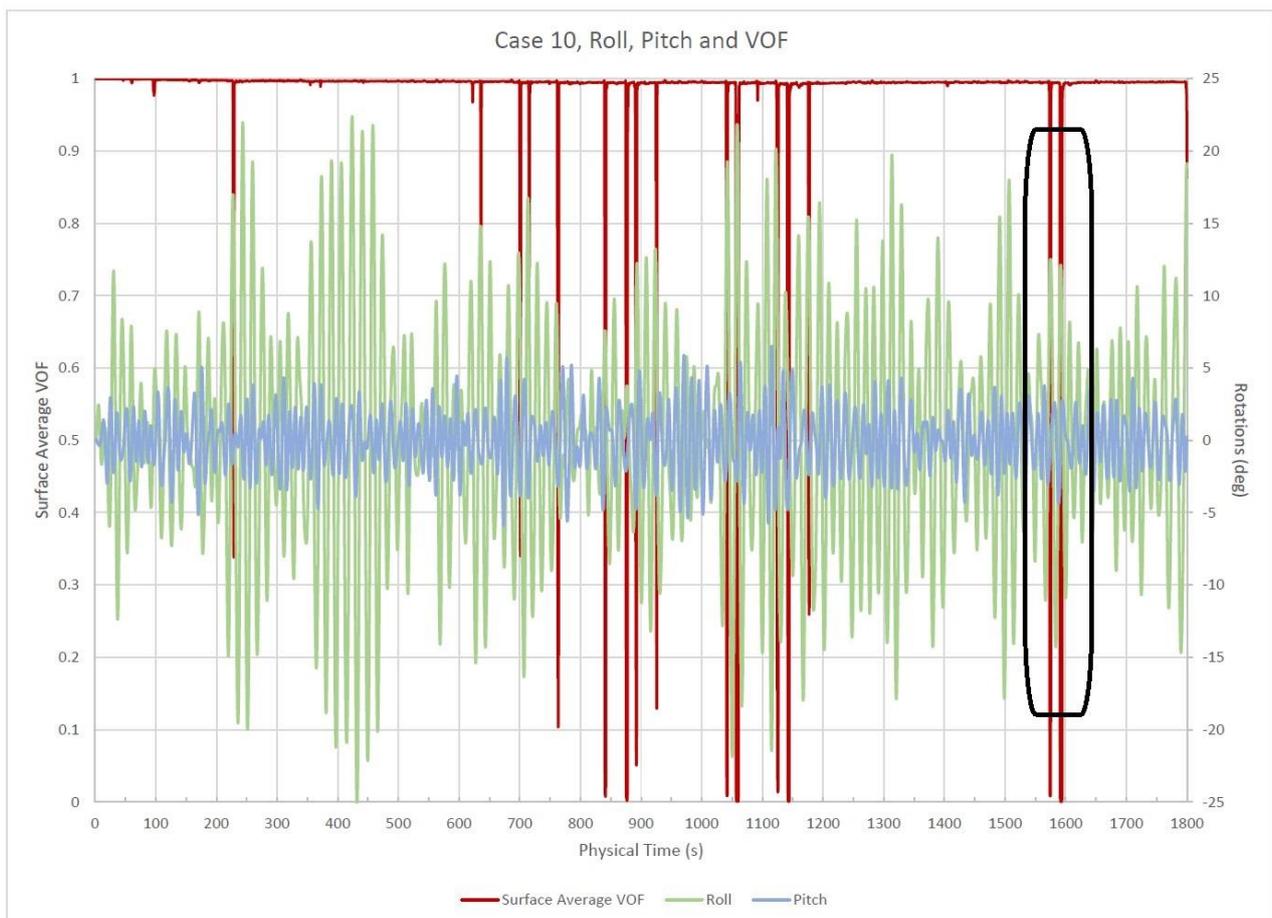
The results of all four simulation cases indicate exposure of the suction pipe to air a various number of times and for different durations. For the case which seems to be the worst of the four, 19 events of suction of air are detected with duration of up to 5 seconds.

Figure 54: Graphical representation of results of CFD analysis from Lloyd's Register. Source: Lloyd's Register

The blue graph represents the pitch angle and the green graph represents the roll angle. Both of these are linked to the y-axis on the right side of the diagram. The red graph represents the fraction of the suction pipe inlet opening that is covered by oil and is linked to the y-axis shown on the left side of the diagram. Whenever the red graph drops below 1 the suction pipe inlet opening is partially exposed to air. When the red graph reaches the value of 0, the complete opening of the suction pipe inlet is exposed to air. LR has informed that the suction of air events have a duration of approximately 1.2 to 5 seconds each for the above illustrated case. Several of the events of suction of air seem to occur while the pitch and roll angles are less than the angles prescribed by the SOLAS regulation, as indicated by the black circle in the above graphical representation.

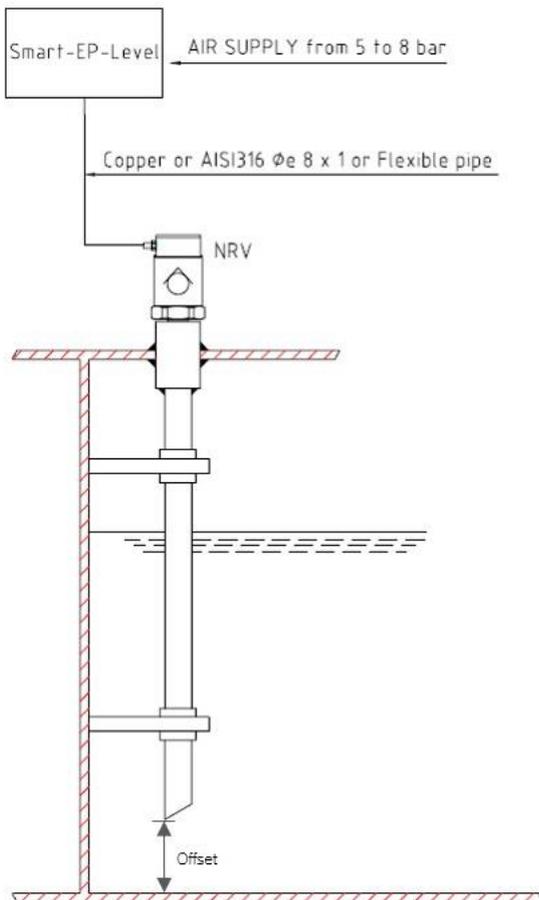
The installation of the sensor system in the lube oil sump tank is shown in Figure 57. As shown in the figure, the tube is installed with an offset, measured as the distance from the end of the tube down to the tank bottom. In addition to the external air supply, the module requires input from two barometric reference sensors for measurement correction.

Figure 57: Installation of the level gauge system in the lube oil sump tank. Extract: The system data sheet, S-SEPL-TM-V21. Rev. 20, Wärtsilä APSS srl.

The offset is the height from the tank bottom to the bottom of the sensor tube, see Figure 57. The design offset for the sensor tubes in the lube oil sump tanks for *Viking Sky* and its sister vessels was 60 mm. According to the yard, the actual as-built height may vary due to available pipe-length and accuracy during welding. The offset value in the IAS is adjusted on board during commissioning, aligning the volume from the level transmitter with the volume from manual soundings.

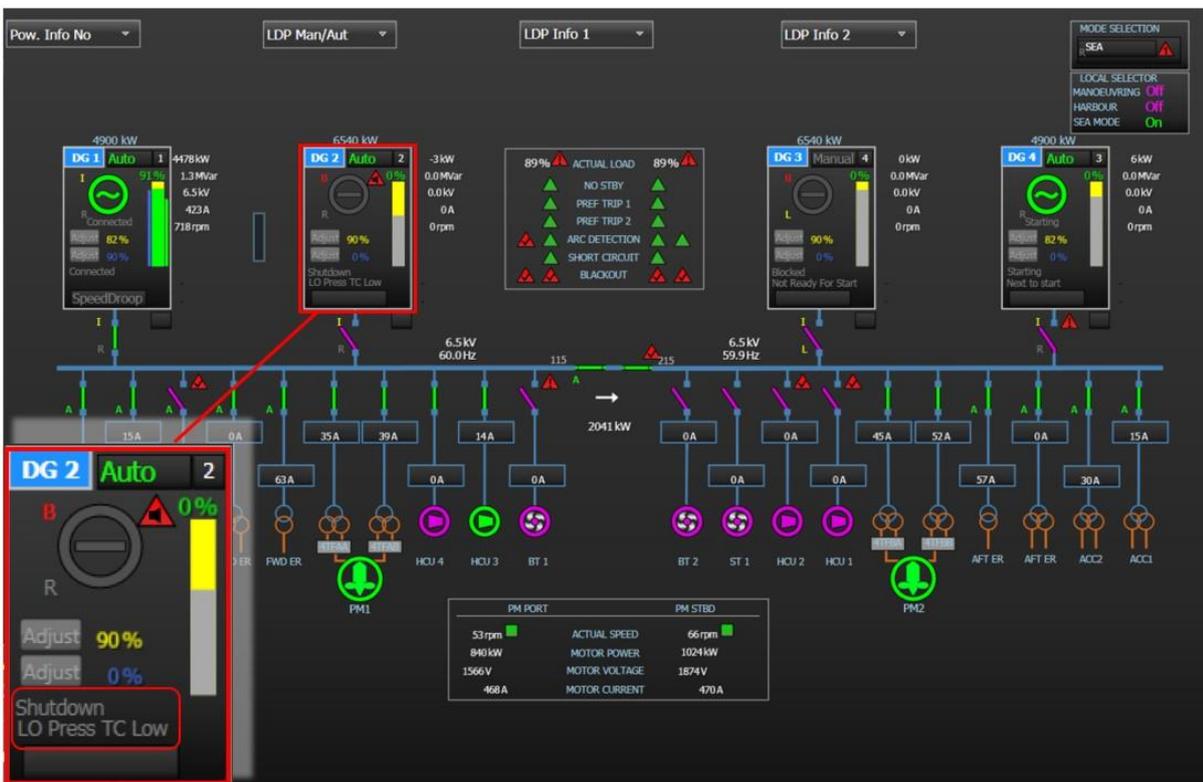
The alarms were also shown in the relevant mimics. An example from the power management mimics is shown in Figure 59, where a red alarm triangle and text describing the alarm indicates low lube oil pressure approximately 2 minutes after DG2 shutdown.

Figure 59: Extract from the power management mimics, showing the low lube oil alarm. Source: IAS/NSIA

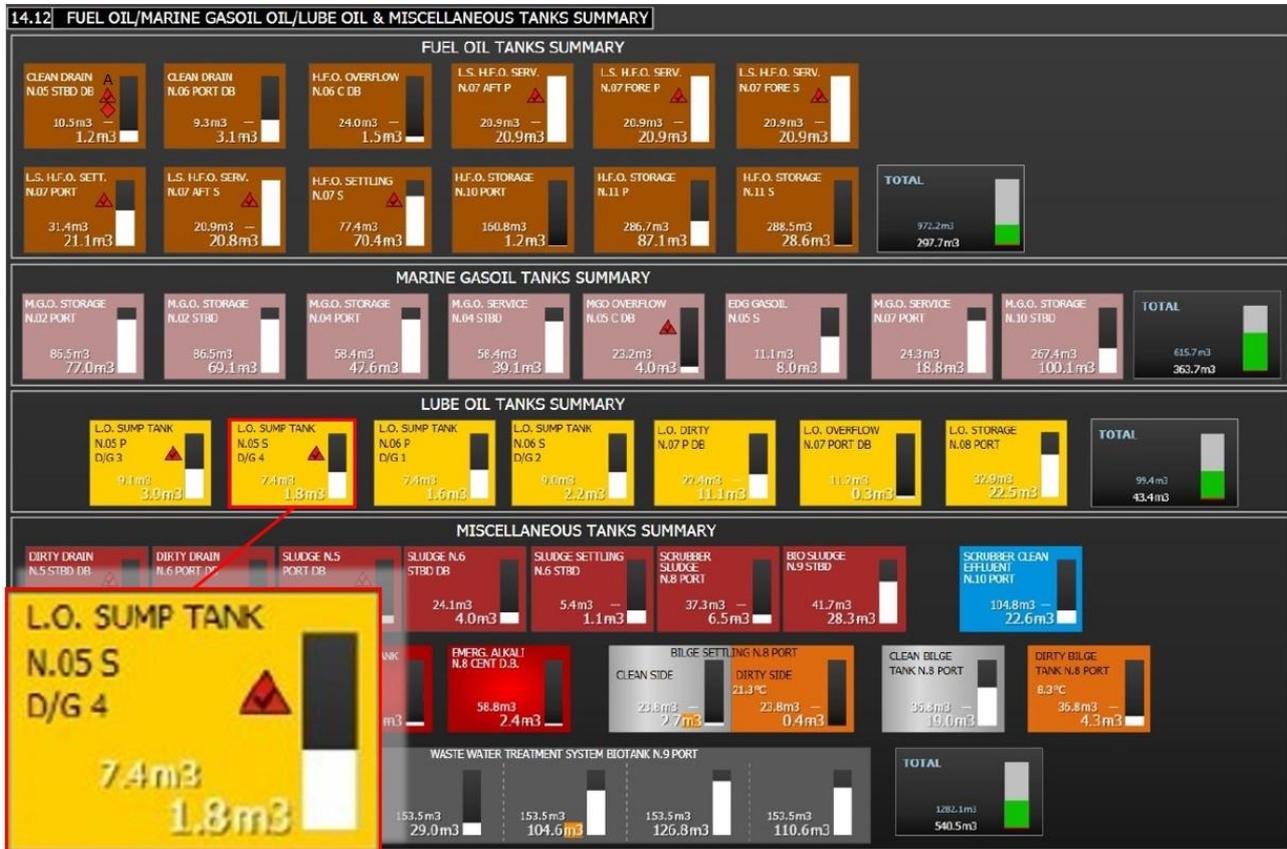
Figure 60 and Figure 61 shows how levels and corresponding alarms were shown in relevant mimics. These two figures show the tank level at the time of the DG4 shutdown at 1345, with details for sump tank 5S (DG4) highlighted. The volume for 5S (DG4) is based on heel and trim compensated and rounded data from NAPA, stated to be 1.8 m³. This corresponds to 24% filling level. The graphical representation of the filling level, represent the direct level measurement of the EP Level Module²⁰, shown to be approximately 40%, see Figure 62.

Figure 60: Extract from the tank mimics, showing the tank levels. Source: IAS/NSIA
