REPORT MARINE 2024/05

*Loss of propulsion and near grounding of
Viking Sky, Hustadvika, Norway
23 March 2019*

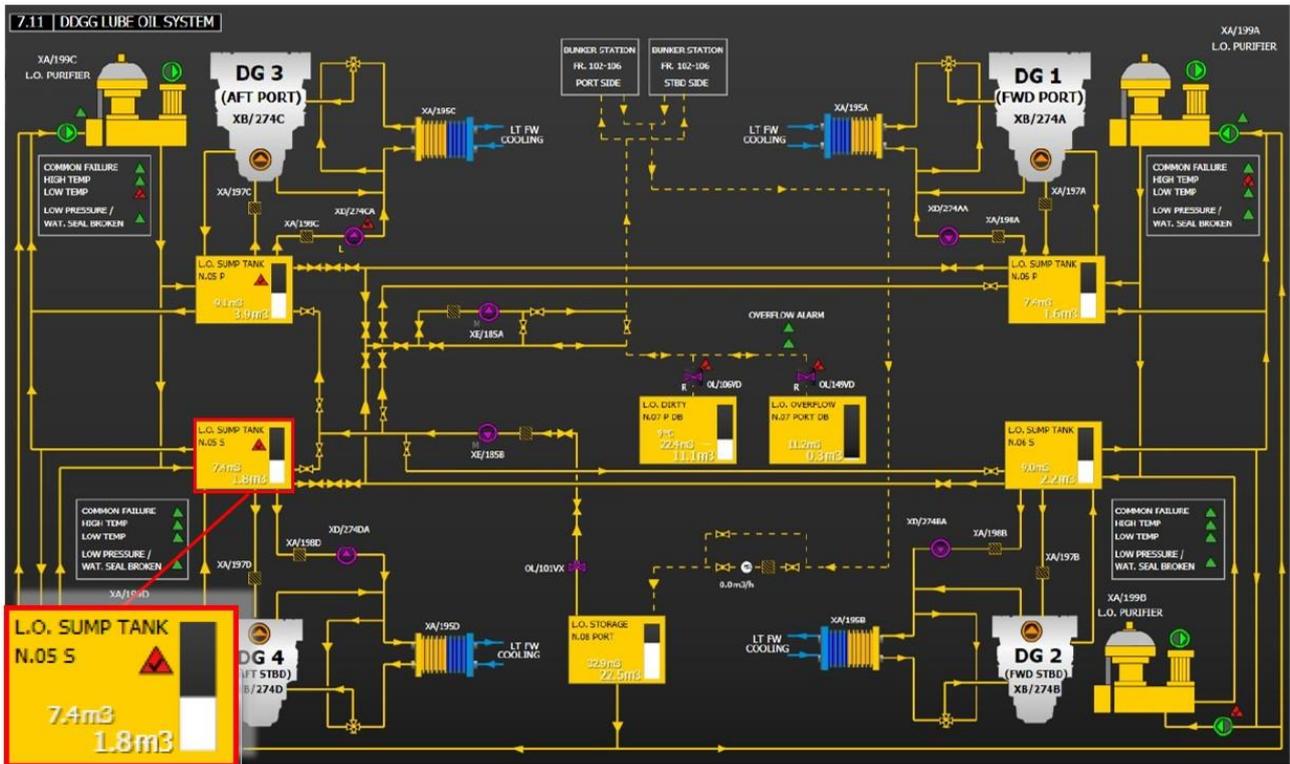
Figure 60 and Figure 61 shows how levels and corresponding alarms were shown in relevant mimics. These two figures show the tank level at the time of the DG4 shutdown at 1345, with details for sump tank 5S (DG4) highlighted. The volume for 5S (DG4) is based on heel and trim compensated and rounded data from NAPA, stated to be 1.8 m³. This corresponds to 24% filling level. The graphical representation of the filling level, represent the direct level measurement of the EP Level Module²⁰, shown to be approximately 40%, see Figure 62.

Figure 61: Extract from the lube oil system mimics, showing the tank levels. Source: IAS/NSIA

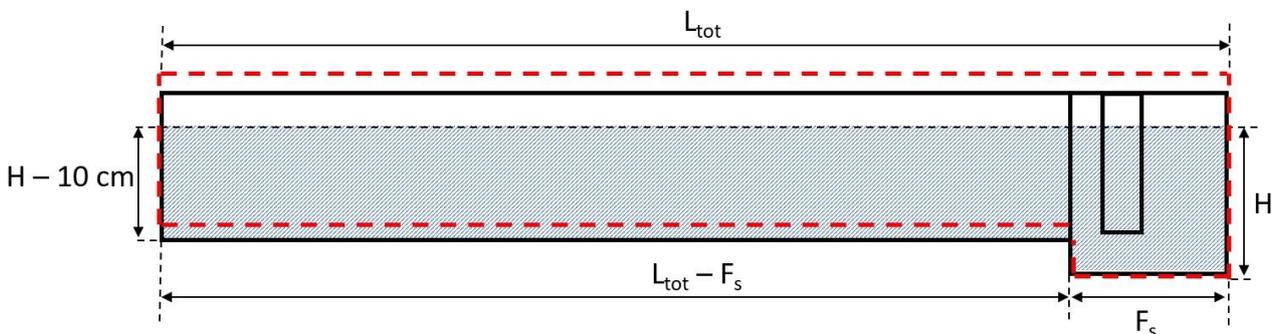
The investigation has identified that there was an error in the 3D model geometry for sump tank 6P (DG1) as it indicated a total tank height of 75 cm instead of 70 cm and a well area of 15 cm depth instead of 10 cm depth. This caused an error in the calculations. The IAS further holds tank capacity tables that are used for conversion of oil level to volume in case the NAPA loading computer is unavailable. The tank capacity table for sump tank 6P (DG1) has the same error as the 3D model. The below sketches illustrate the effect of the erroneous model:

Figure 64: Actual oil volume for a given oil filling height "H". Illustration: NSIA

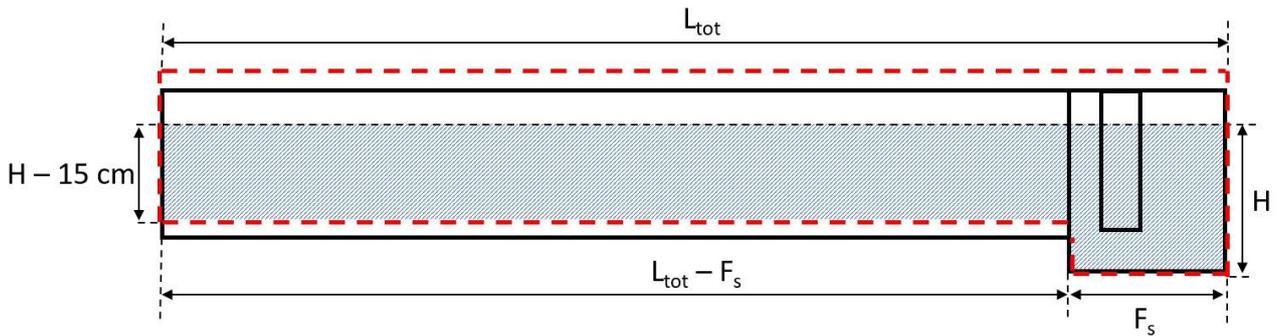
Figure 65: Oil volume calculated by use of the erroneous model for a given oil filling height “H”. Illustration: NSIA

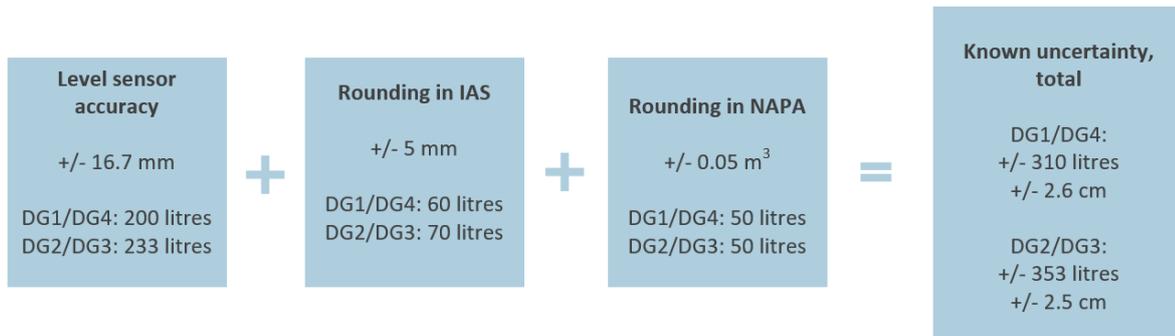
The total, known uncertainty for the remote monitoring system is as shown in Figure 67. It consists of the maximum error for each contributing system which is based on the known measurement uncertainty and rounding in the transactions, as described in the previous sections.

Figure 67: Known, total uncertainty for the remote monitoring system. Illustration: NSIA

Due to the known error in the 3D model, the volume calculation will return a value 568 litres less than the actual oil volume for any given oil height for 6P (DG1). This will come in addition to the uncertainty shown in Figure 67.

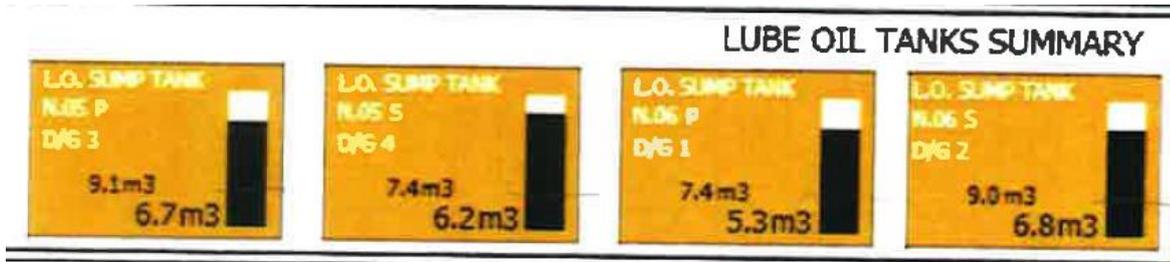
On the day of delivery of *Viking Sky*, 25.01.2017, a printout was made from the IAS with an overview of all tanks content. The below figure shows an extract with the lube oil sump tanks content.

Figure 68: Extract from printed tanks summary on day of delivery. Source: Wilhelmsen

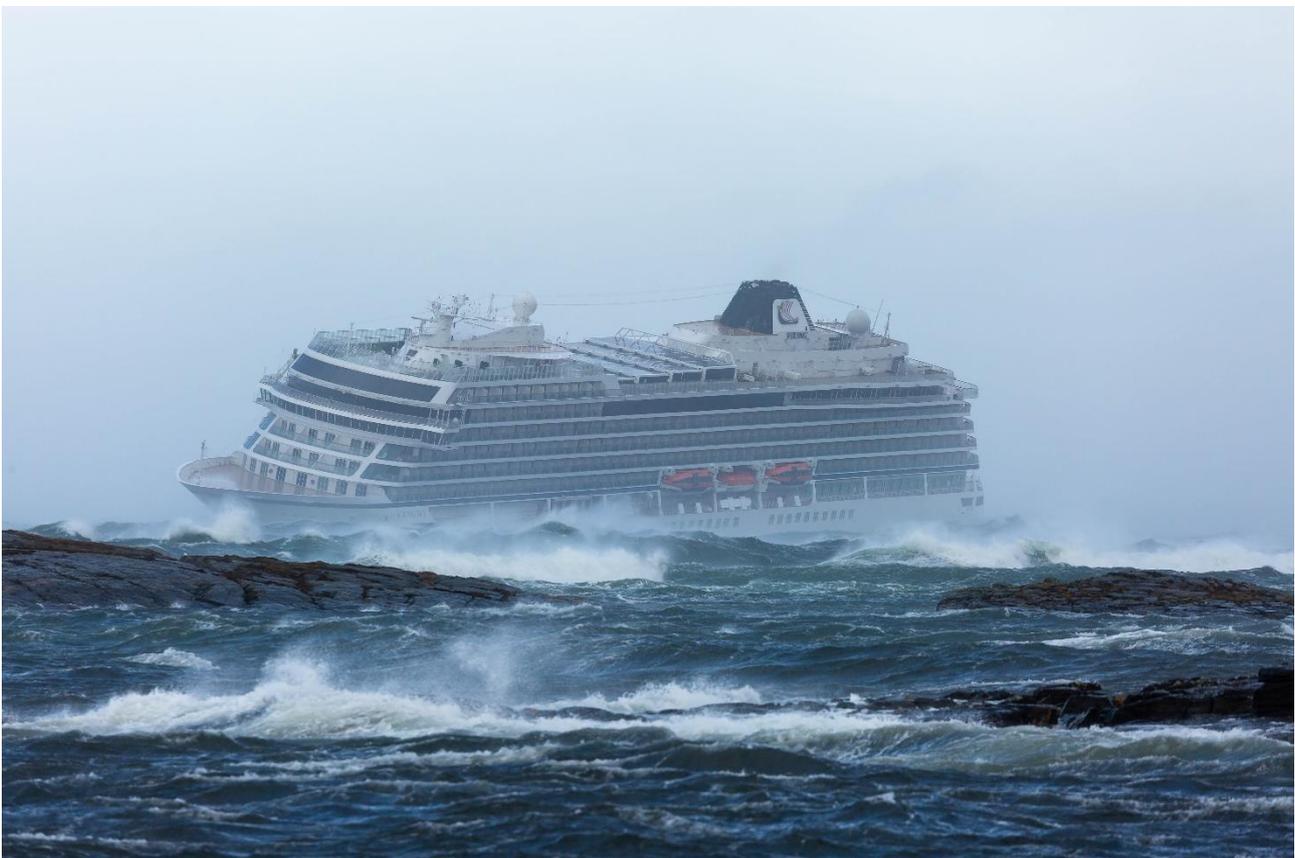
Figure 69: *Viking Sky* in close vicinity to shore and several shallow banks. Photo: Frank Skorgenes

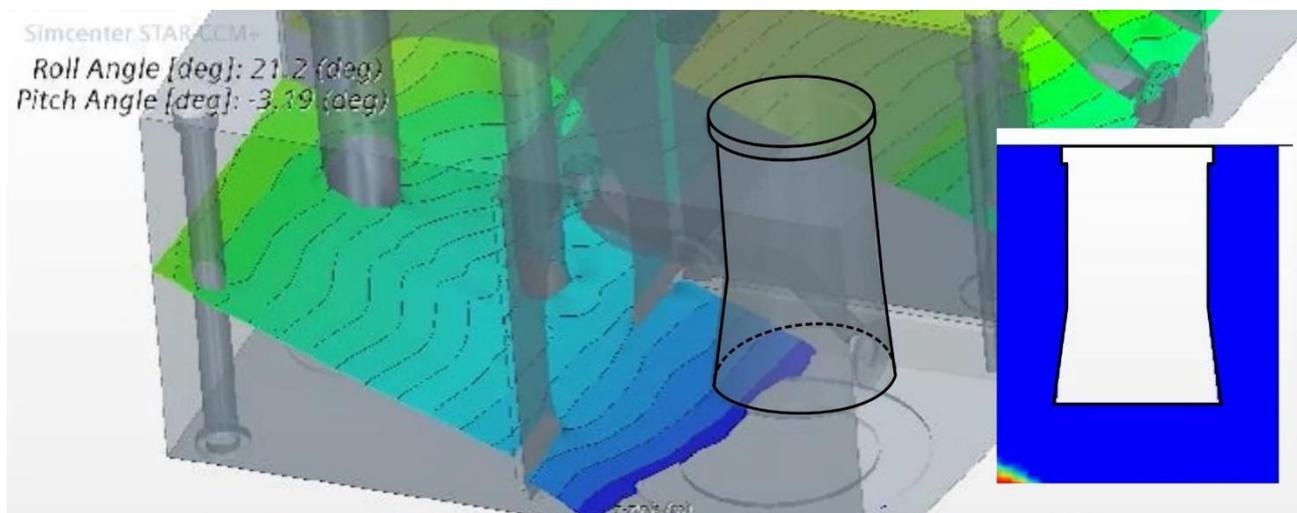
Any exposure to air of the suction pipe inlet opening represents a risk of loss of lube oil pressure and subsequent shutdown, malfunction or even severe damage to the engine. It should therefore be considered outside of the acceptance criteria for compliance with the SOLAS regulation.

As presented in sections 1.8.7.2 to 1.8.7.4, the shipyard, the classification society and SINTEF Ocean (on behalf of the investigation) have carried out CFD simulations of the lube oil behavior under dynamic inclination of the vessel. The simulations have used somewhat different approaches, but all three indicate that within the parameters of the design criteria there are situations where the suction pipe is likely to be exposed to air. The NSIA therefore concludes that the lube oil sump tank design must be considered non-compliant with the SOLAS regulation.

Figure 70: Illustration from the CFD simulation showing the suction pipe completely exposed to air. The multi-coloured surface represents the surface of the oil. The illustration in the box to the right shows a 2D side view of the suction pipe. Source: SINTEF Ocean/NSIA

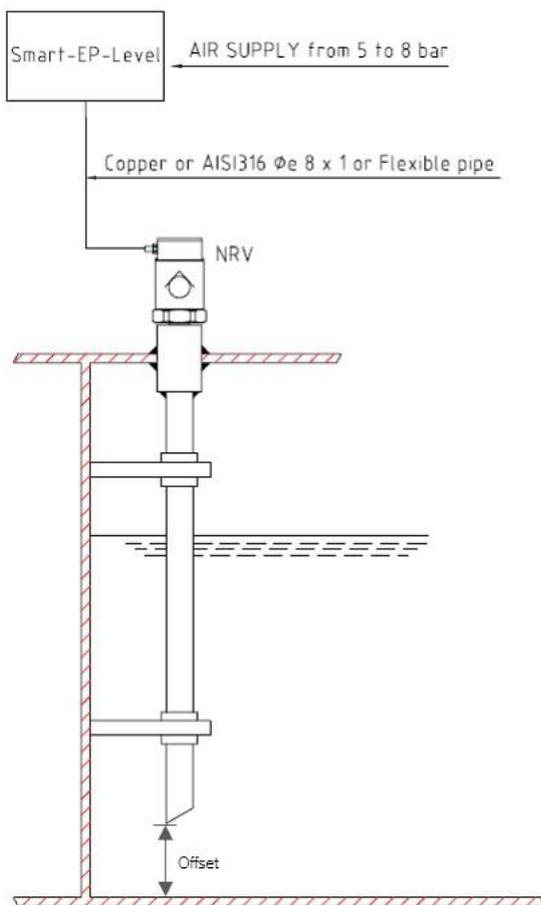
In addition, the level measurements depended on the manually set parameters for oil density and sensor offset. The sensor offset represents the physical fixed distance from the bottom of the tank to the bottom of the level sensor tube, see Figure 72. This will never actually change unless the sensor tube is cut loose and rewelded in a different position.

Figure 72: Illustration showing the physical offset. Extract: The system data sheet, S-SEPL-TM-V21. Rev. 20, Wärtsilä APSS srl.

The shipyard has explained that the design offset for *Viking Sky* and its sister vessels was 60 mm. However, the importance of the offset and its direct influence on the accuracy of the level measurements was not recognised. Therefore, the as-built offset could vary, and the actual offset was never measured or recorded. Furthermore, the shipyard systematically made adjustments to the offset value in the IAS during commissioning to align the manual and remote level readings. In a similar manner, both the crew and service engineers from the equipment maker has later altered the offset value to “calibrate” the manual and remote measurements. By doing so, a measurement error that was caused by an unknown reason was masked by introducing an additional error. “Calibrating” the manual and remote level readings through manipulation of the offset merely aligns the two measured values for that exact oil level. As soon as the level of oil changed, the remote measurements would diverge from the manual soundings and the crew would again experience the system as “out of calibration”.

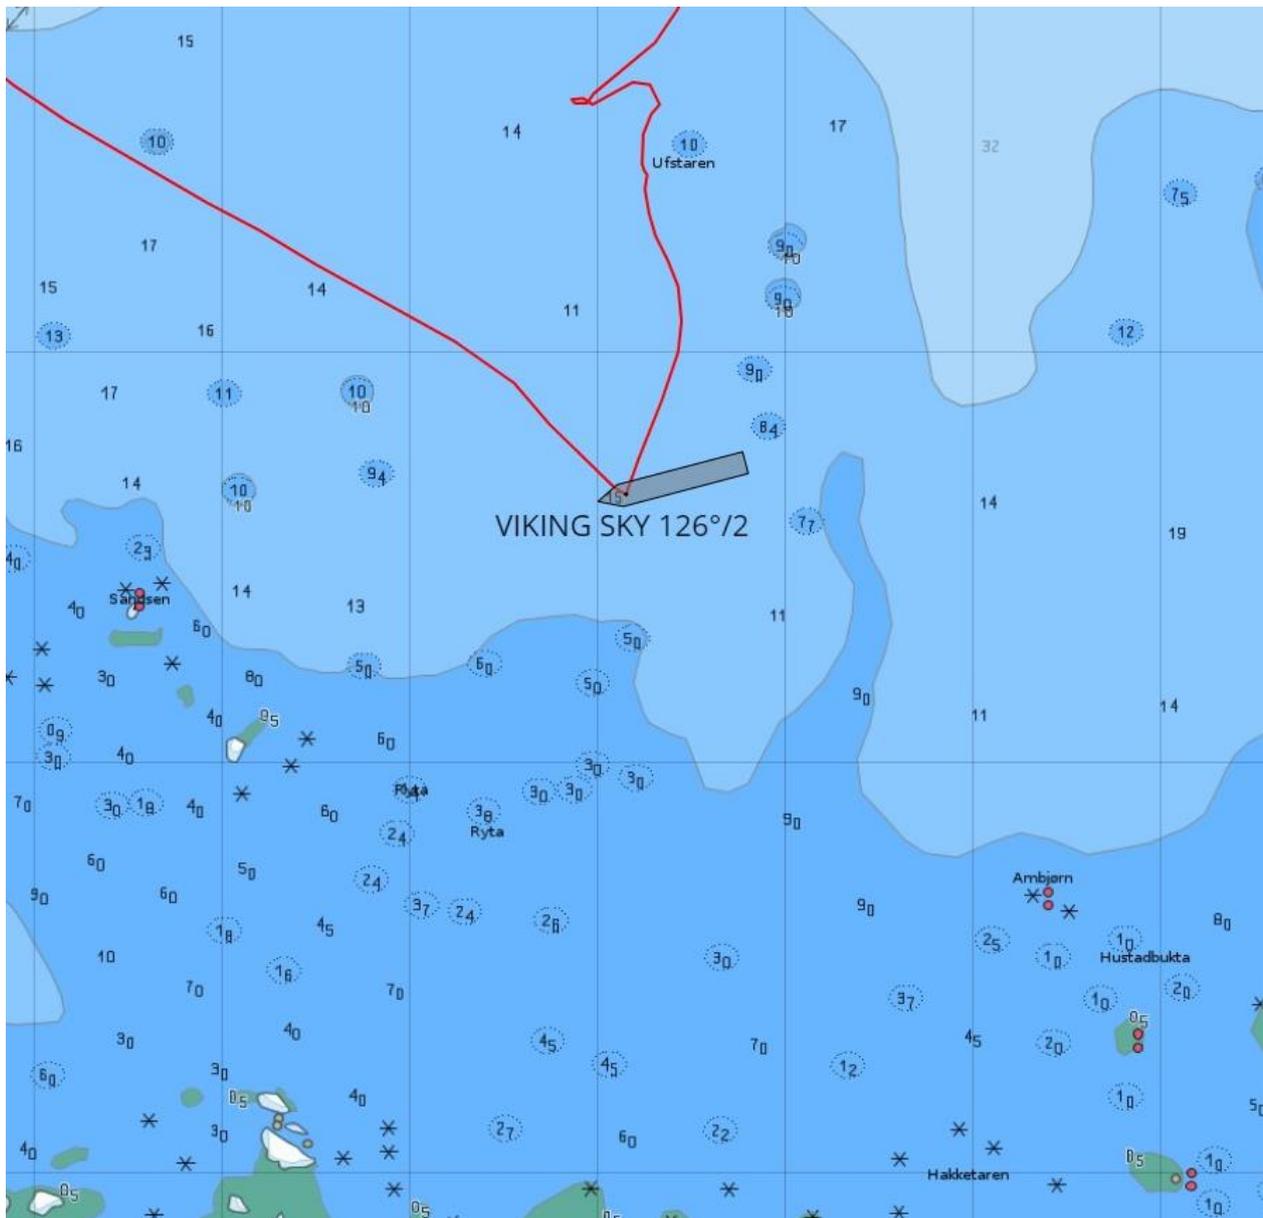
The electronic evidence recovered from the IAS show that it took 14 minutes from the blackout until refilling of the lube oil sump tanks was started. Still, the engineers continued to struggle to restart and connect the DGs, and the first DG was connected to the MSB about 10 minutes later. It took another 9 minutes further to restore any propulsive power. When eventually all the DGs had been successfully connected to the MSB, DG2 was left in manual load sharing mode with DG1 and DG4, which were in automatic mode. The vessel drifted across shallows and rocks and came to within a ship's length of running aground before sufficient propulsion power was restored to turn the vessel and slowly move towards deeper waters, see Figure 73 and section 1.2.4.

Figure 73: Viking Sky in close vicinity to several shallow banks, drifting towards shore. Source: The Norwegian Coastal Administration AIS

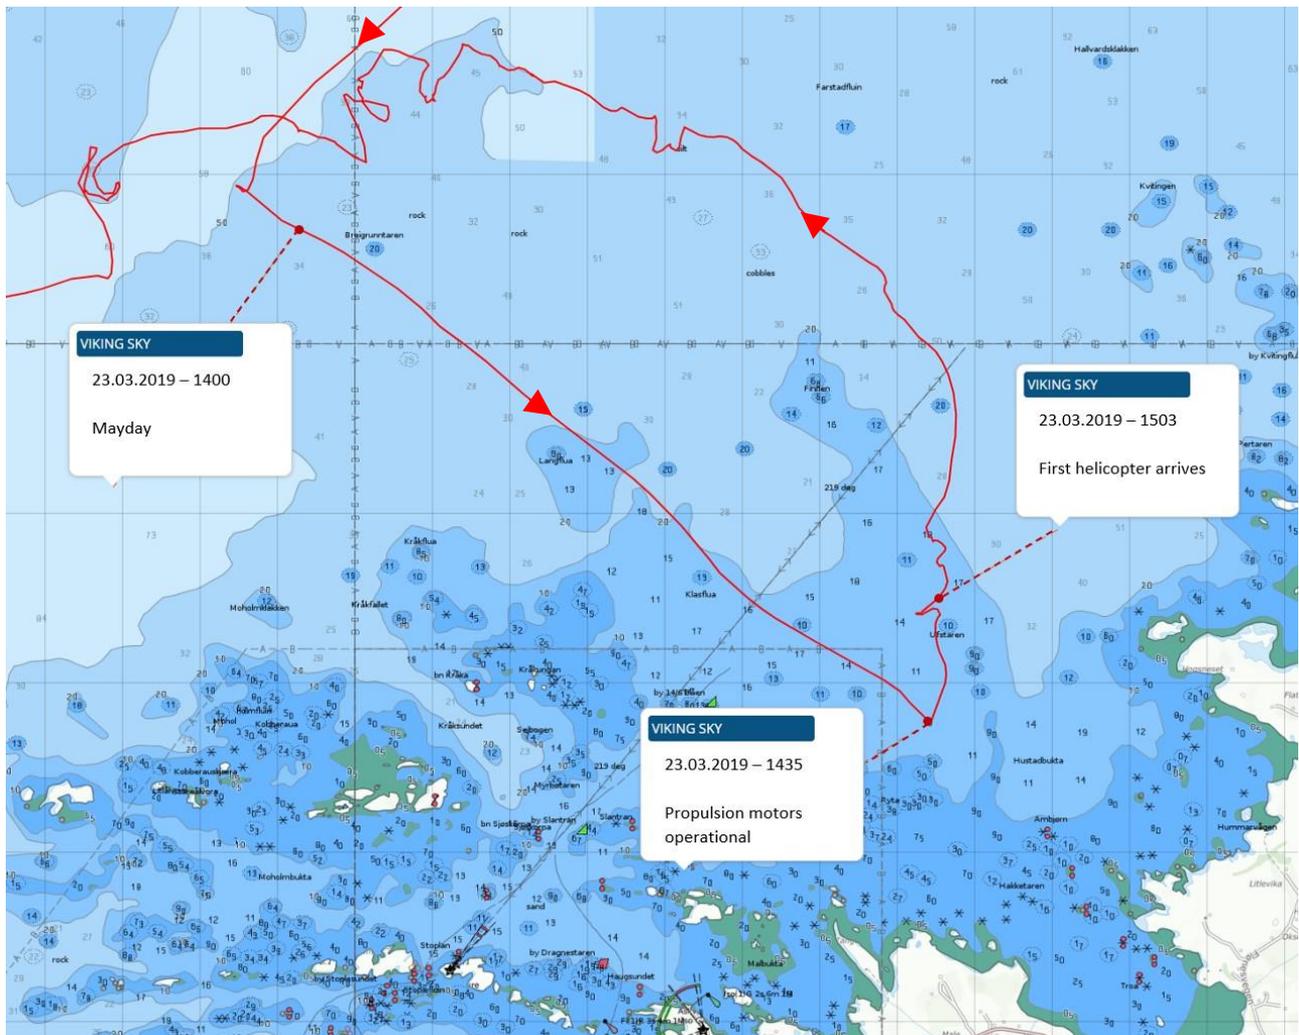
As seen from the sequence of events in section 1.2.5, the first helicopter arrived at the scene approximately one hour after the blackout and 25 minutes after they had restored power, see Figure 74.

Figure 74: Arrival of first helicopter. Source: The Norwegian Coastal Administration/NSIA
